**PROPOSED RESORT  
DEVELOPMENT AT  
PARADISE PARK,  
SMITHFIELD,  
WESTMORELAND**

**ENVIRONMENTAL  
IMPACT  
ASSESSMENT**

**FINAL V. 2**

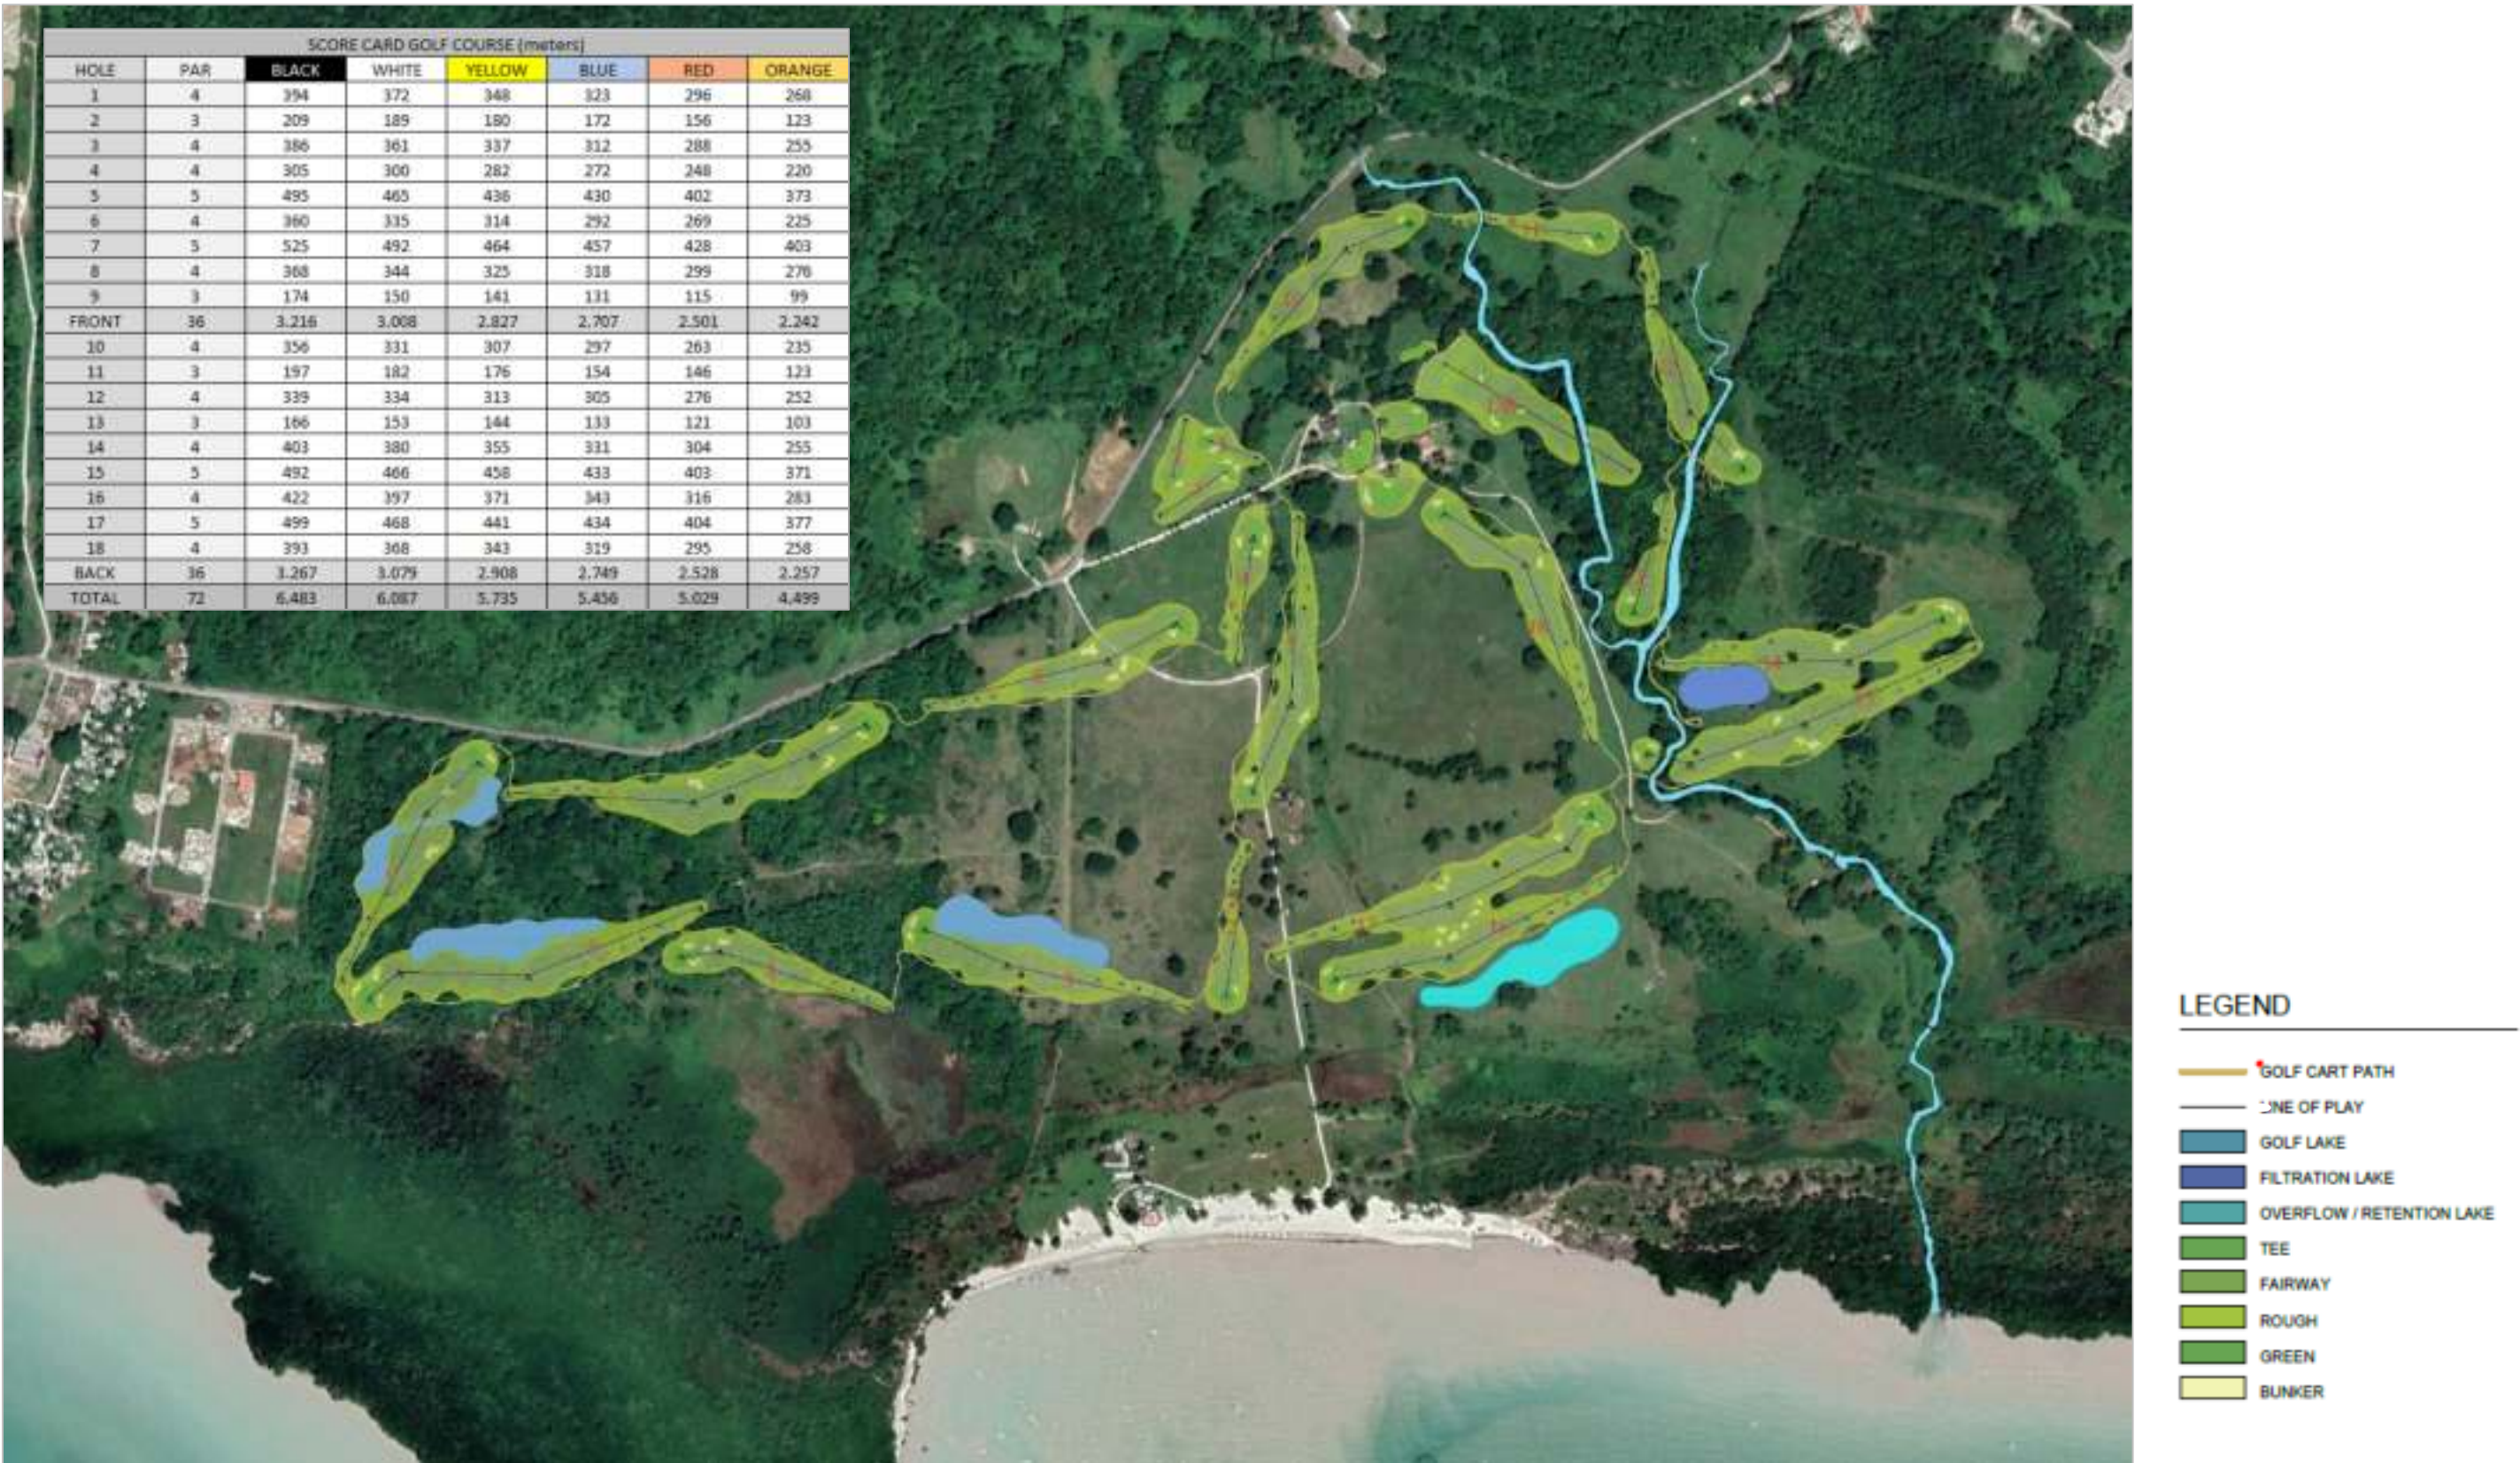
Figure 3-19 Proposed golf course design

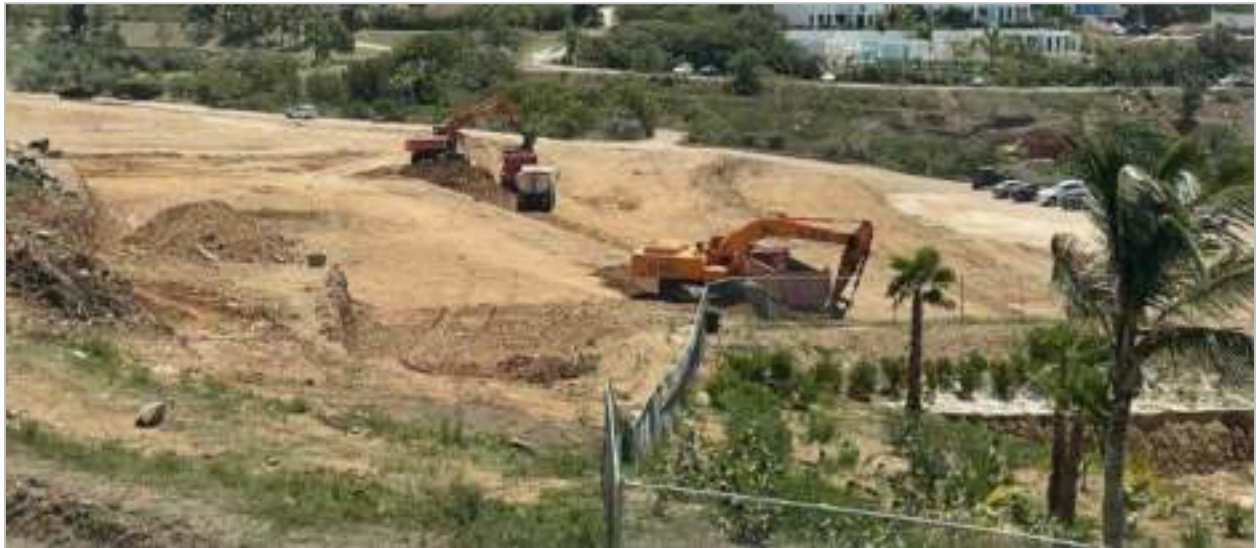
Plate 3-3      Mass earthwork process, including clearing the land with excavators, moving soil, and compacting the ground to ensure a stable foundation for construction.

- **Environmental Controls Installation:** Initial environmental controls, such as silt fencing and check dams, will be installed to prevent silt migration and protect surrounding areas and waterways.
- **Clearing, Grubbing, and Mass Excavation:** Site clearing will begin with mass excavation aligning with the planned development contours (Plate 3-3). The excavation work will be conducted by qualified operating engineers to meet design requirements with minimal erosion.
- **Soil Management and Compaction:** Large excavators will remove and load earth onto heavy-duty trucks, redistributing soil to areas needing elevation increases. The soil will be spread and compacted to achieve 95% modified compaction specifications, verified by a third-party testing agency.

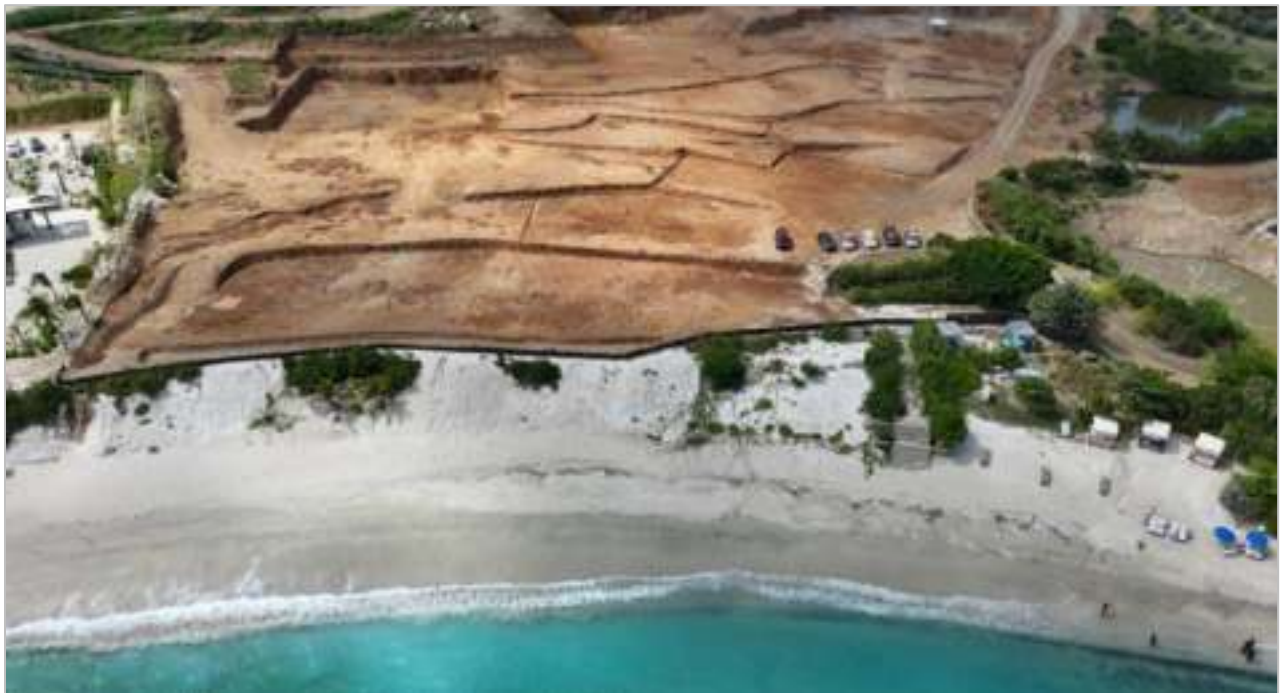
Plate 3-4 Clearing and rough grading completed in advance of building foundations. Note silt fence (black line) installed at bottom of excavation line protecting the beach from silt /erosion.

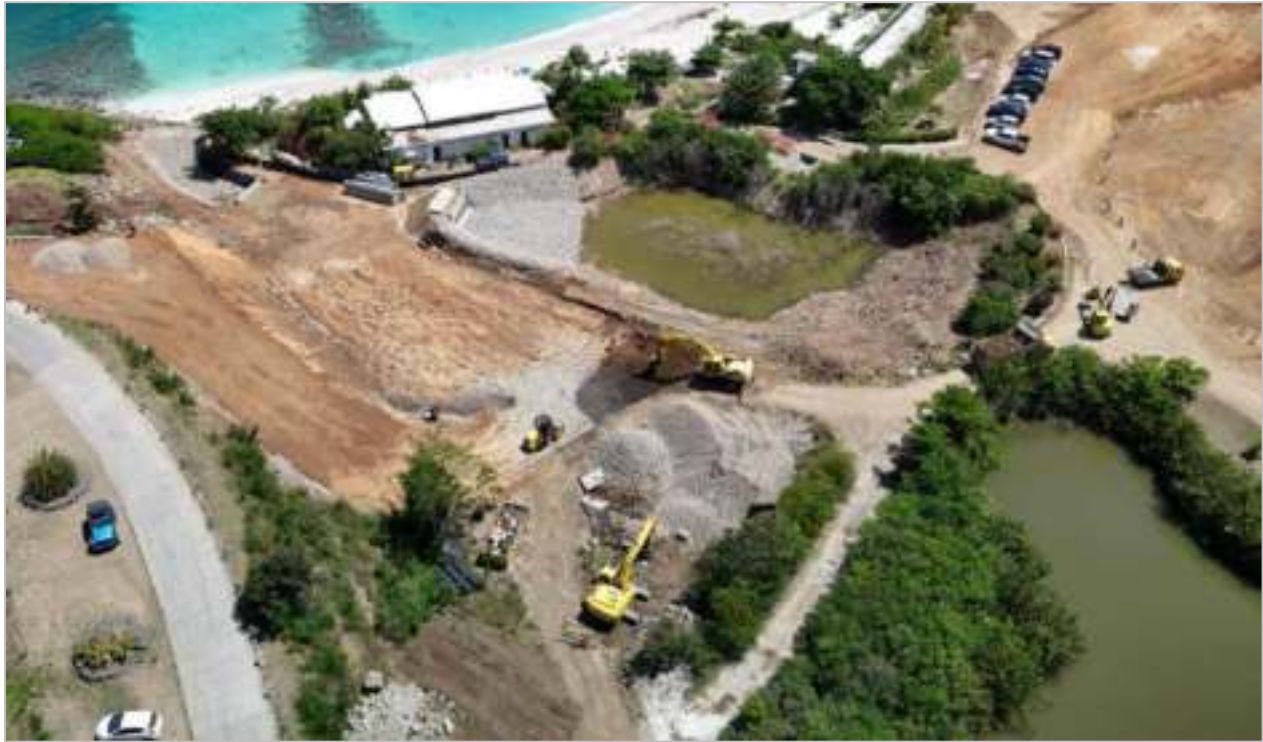
Plate 3-5 Example of storm detention ponds with outflow drainpipes at head wall and riprap protection.

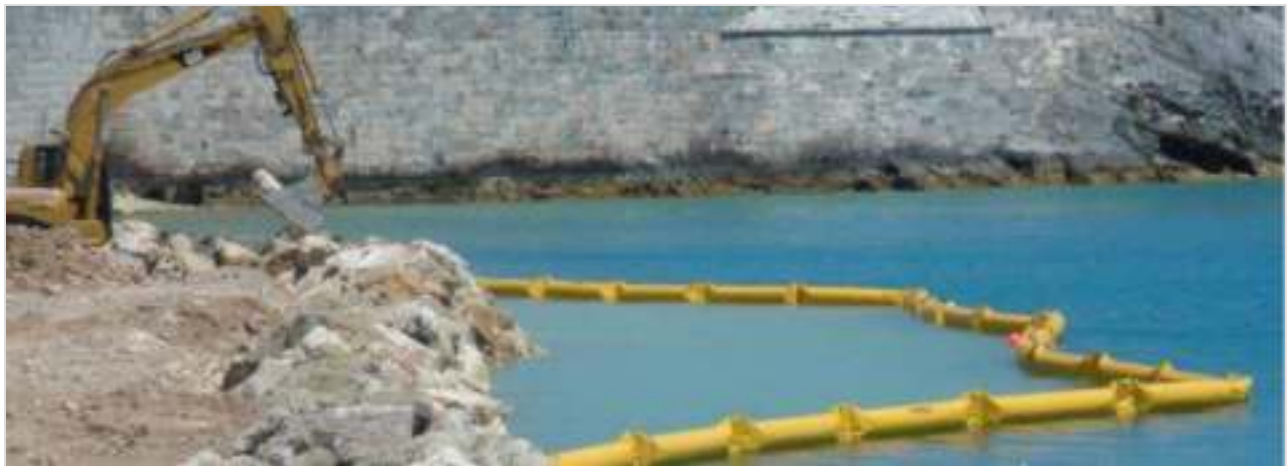
Plate 3-6 Example of a turbidity barrier

Turbidity barriers will be used around all sea works to minimize the leakage of silty material to sensitive areas (Plate 3-6 and Figure 3-47). Turbidity will also be monitored daily at recommended locations by the environmentalist at each work area in the sea where construction occurs. Where turbidity measurements exceed NEPA standards due to marine construction operations, work will stop until normal conditions recover.

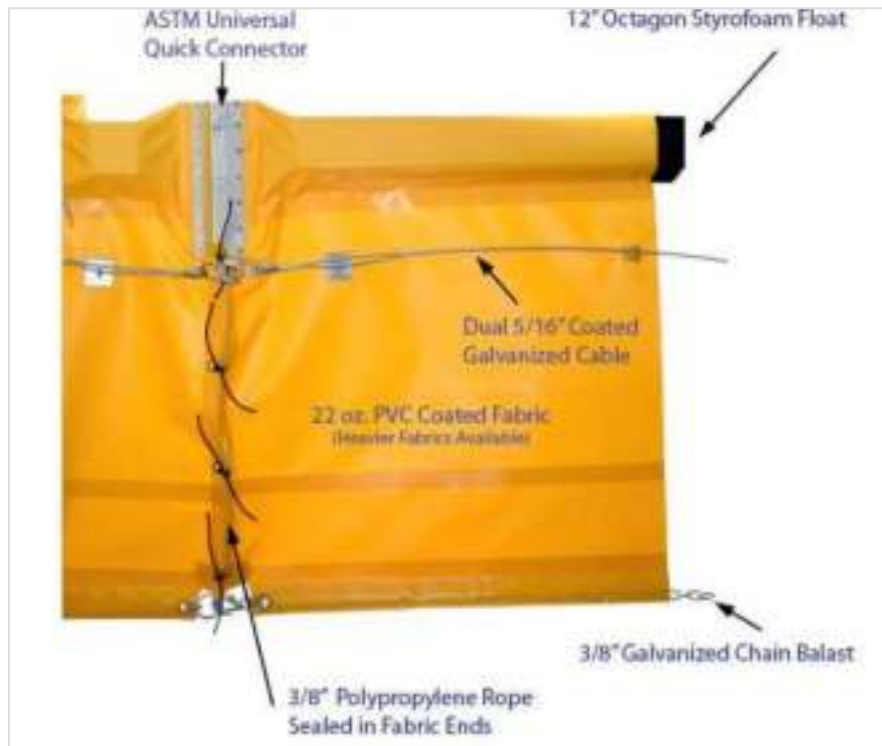
Figure 3-47 Specifications of a Mark III turbidity barrier

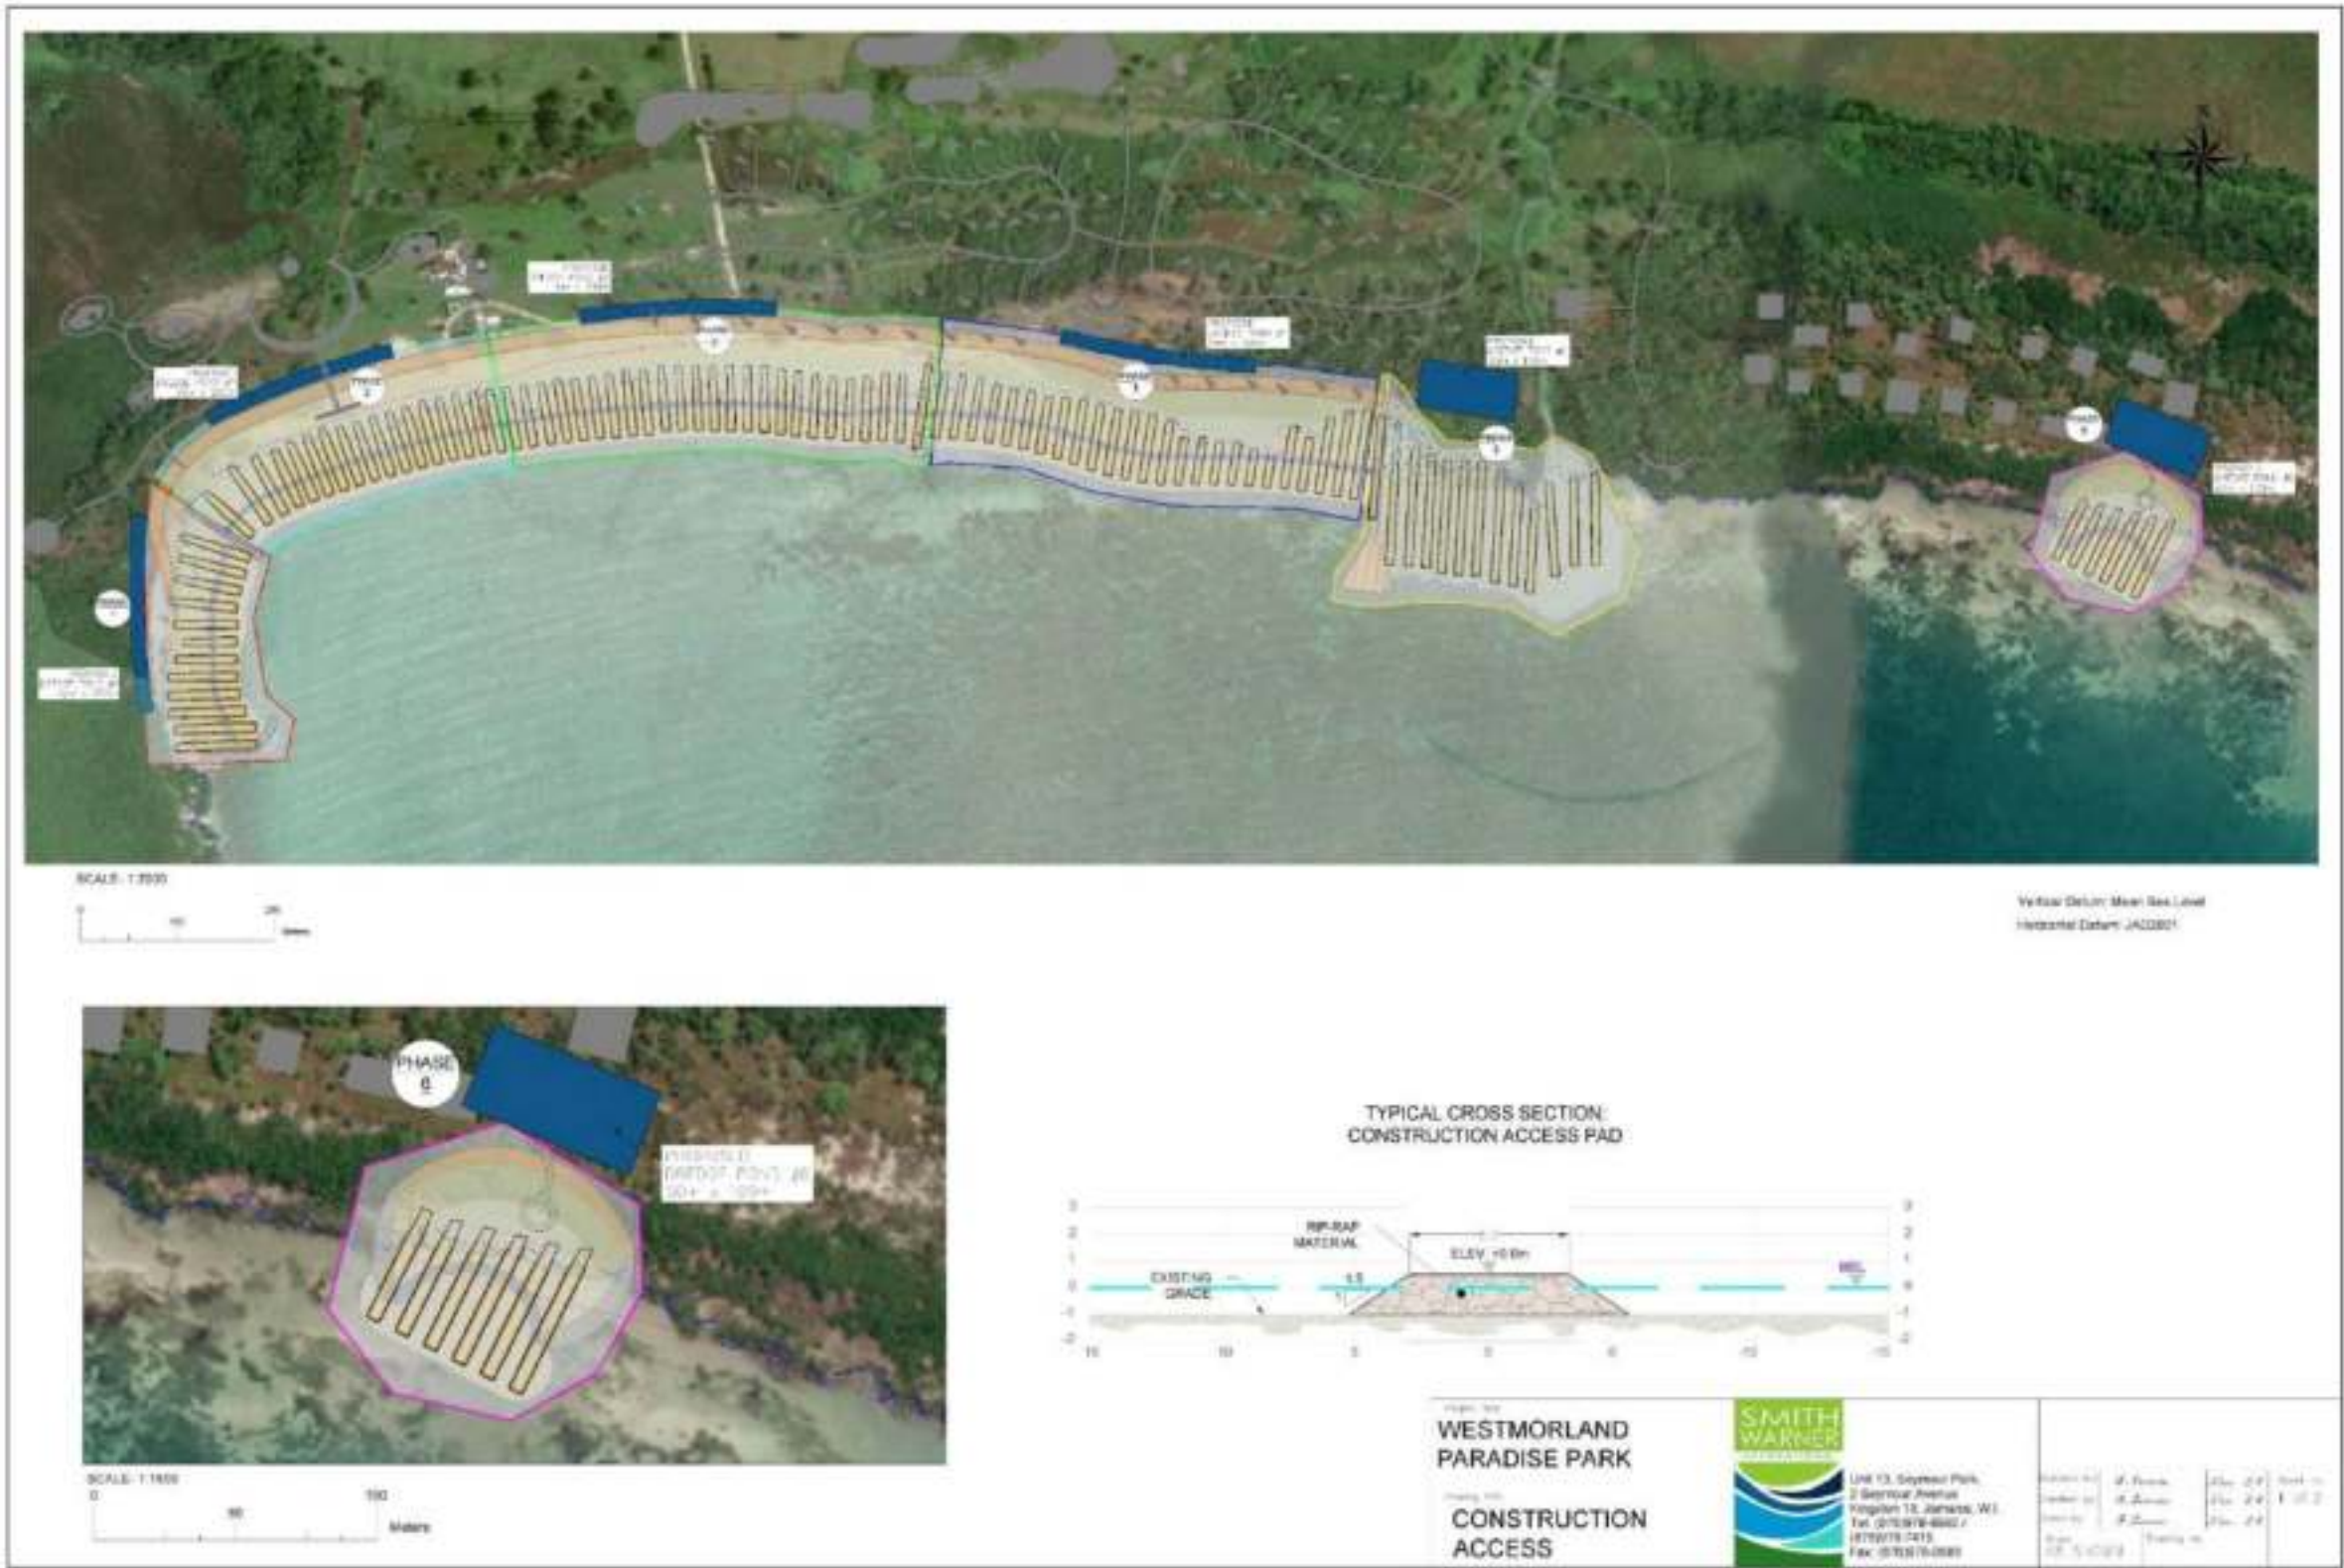
Figure 3-48 Phases, settling ponds and temporary access pad locations

Liquid waste management	Washing activities should be conducted close to the existing areas of ponding. This will allow for runoff to be contained within the property boundary and allowed to infiltrate. Settling ponds will be dismantled and material disposed at an approved landfill (locations in Figure 3-48).
Control of air, dust, water, and noise pollution	Construction will be confined to the working hours of 8 a.m. to 5 p.m. to reduce the disturbance to nearby properties. Equipment will be well maintained and checked daily for leaks or excessive exhaust. If a piece of equipment is malfunctioning, work with that equipment will be stopped and the equipment repaired.
Control/storage of fuels and other dangerous substances	Fuels/fluids and small tools will be stored in a locked equipment container to prevent tampering with or unauthorised access.

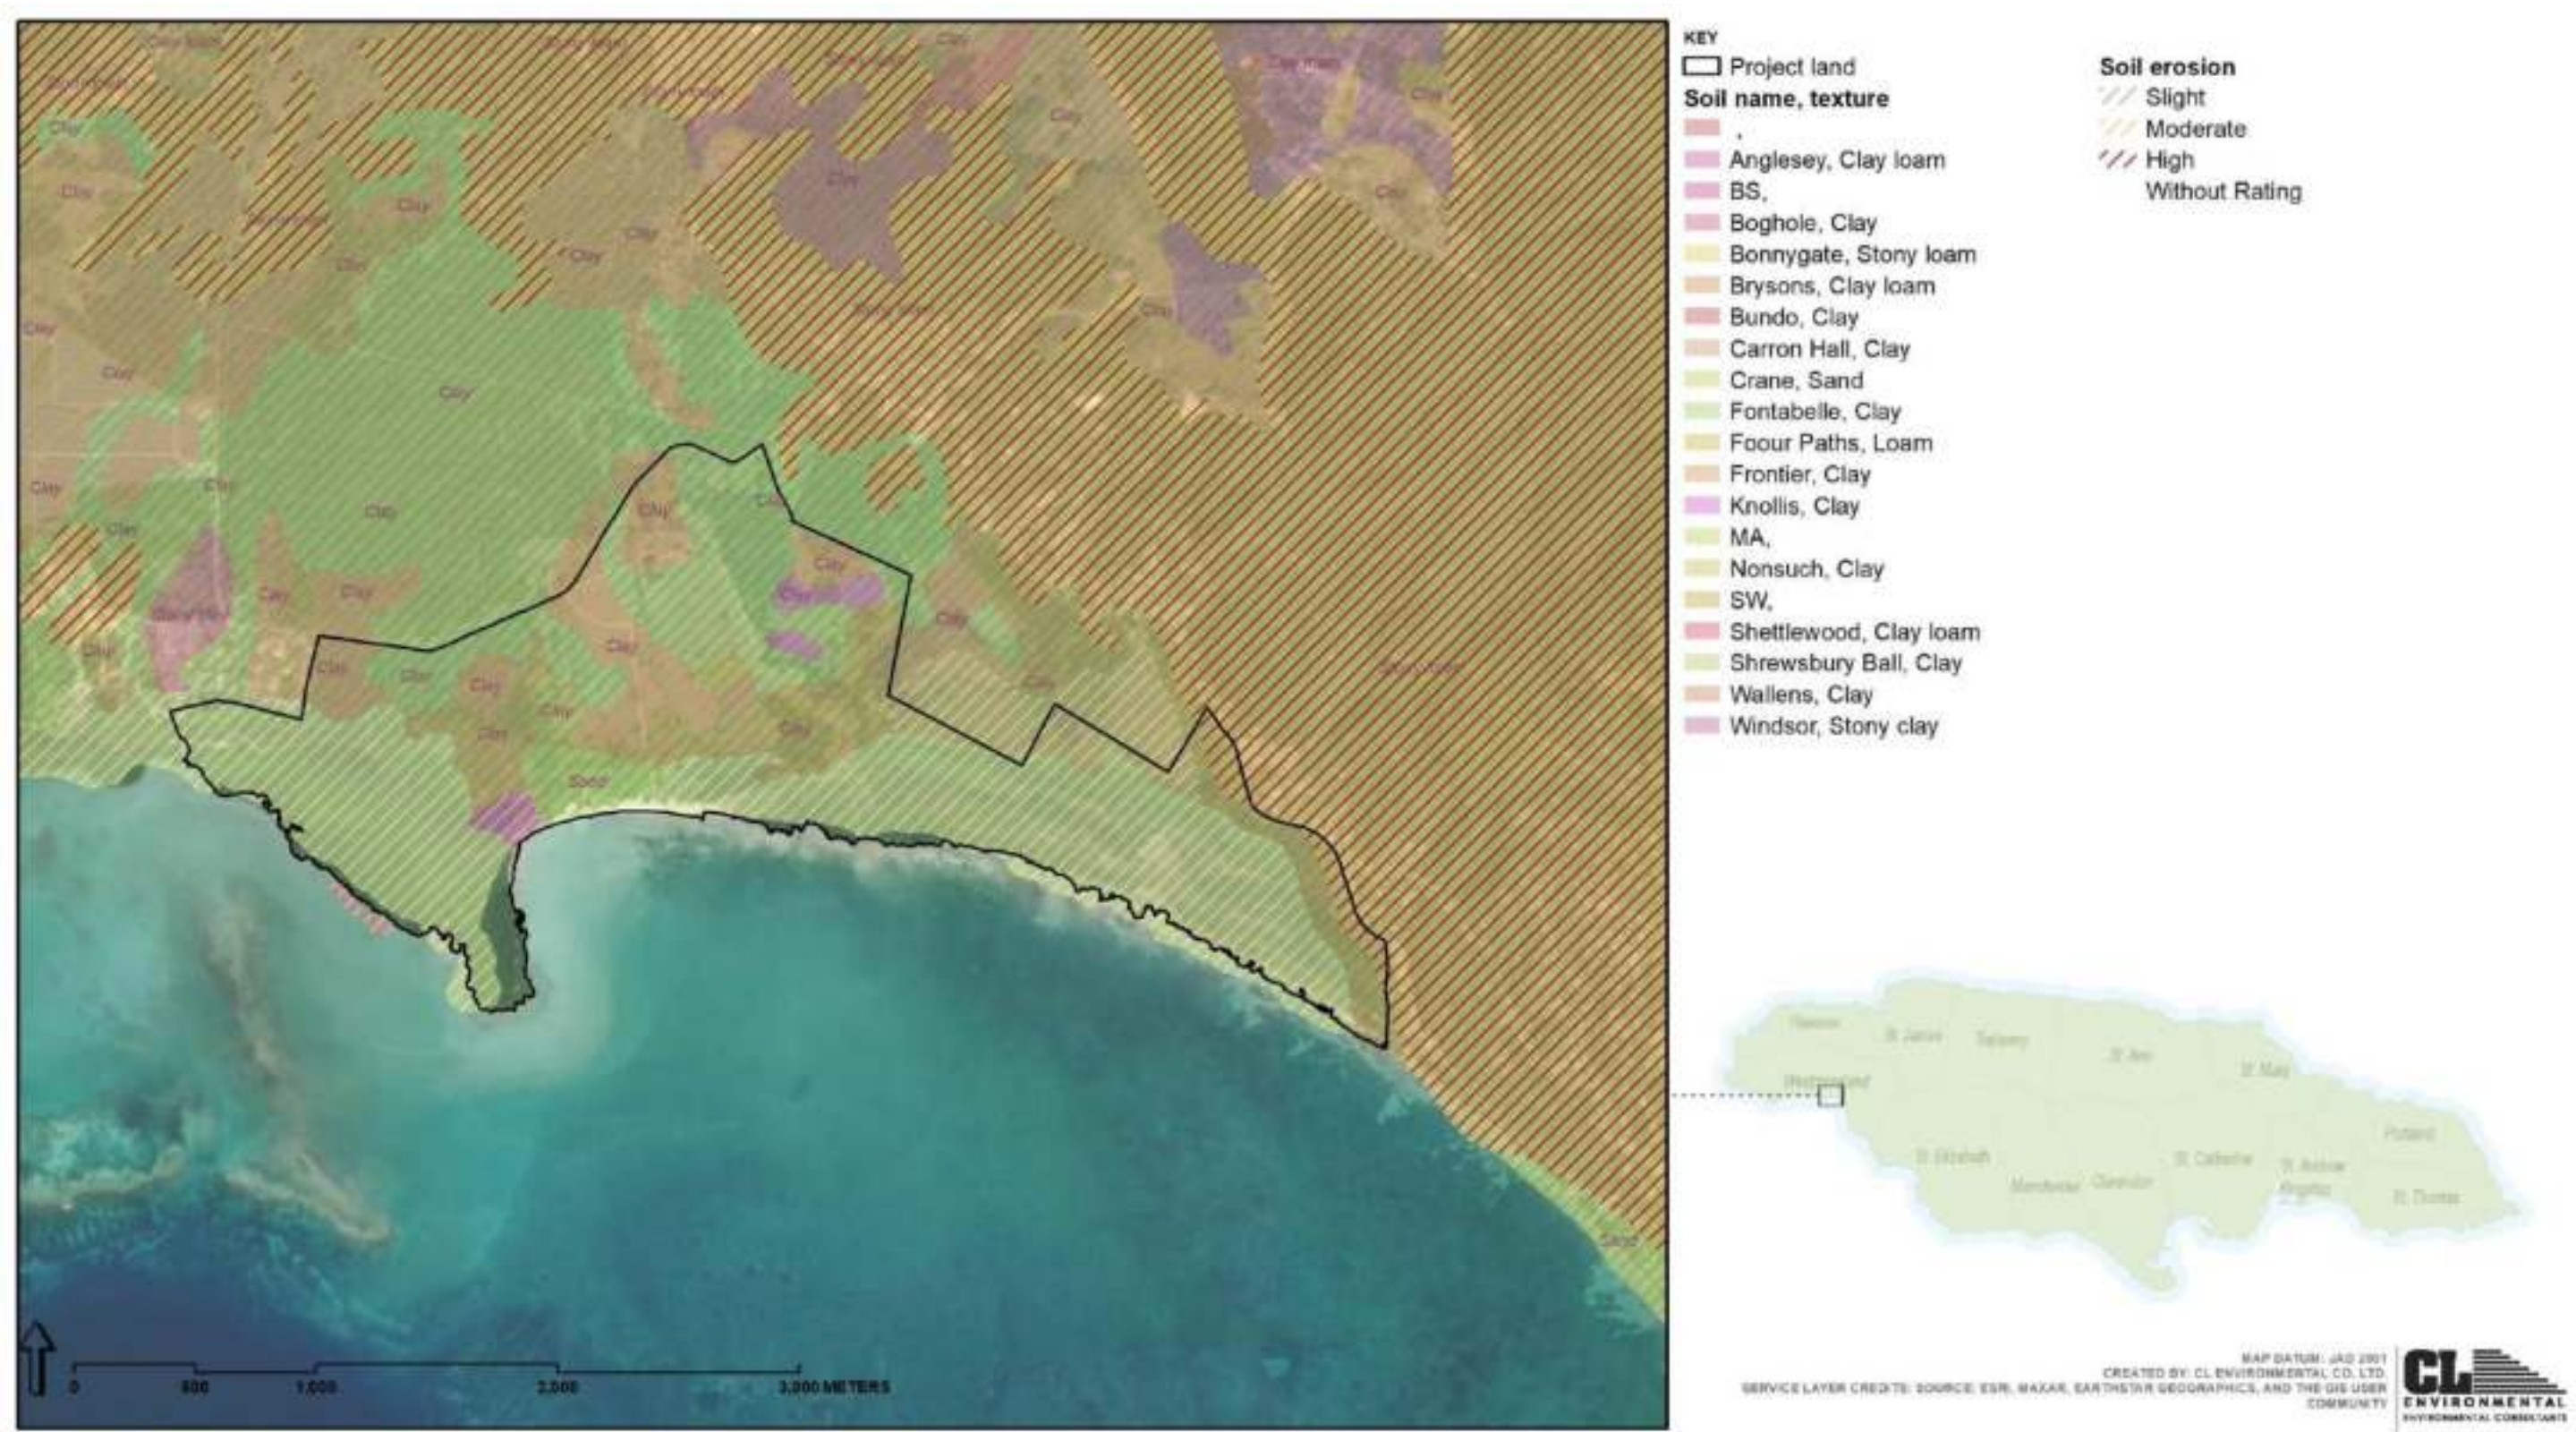
Figure 4-4 Soil type and erosion potential in the project area

The soil types in the area are heterogeneous; on the project land, there are 12 distinct soil types, with the predominant texture being clay in the interior sections of the land, while sand is more commonly found towards the coastline (Figure 4-4, Table 4-1).

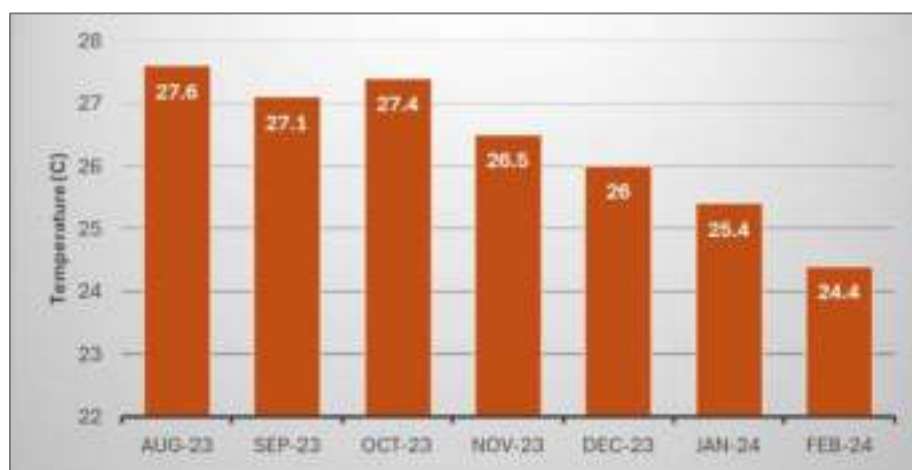
Figure 4-10 Average monthly temperature over the assessment period

August to October were slightly warmer months and had slightly higher humidities compared to the other months (Table 4-2). December, January and February had the highest wind speeds while December had the highest total rainfall (64.94 mm) (Figure 4-10 to Figure 4-13).

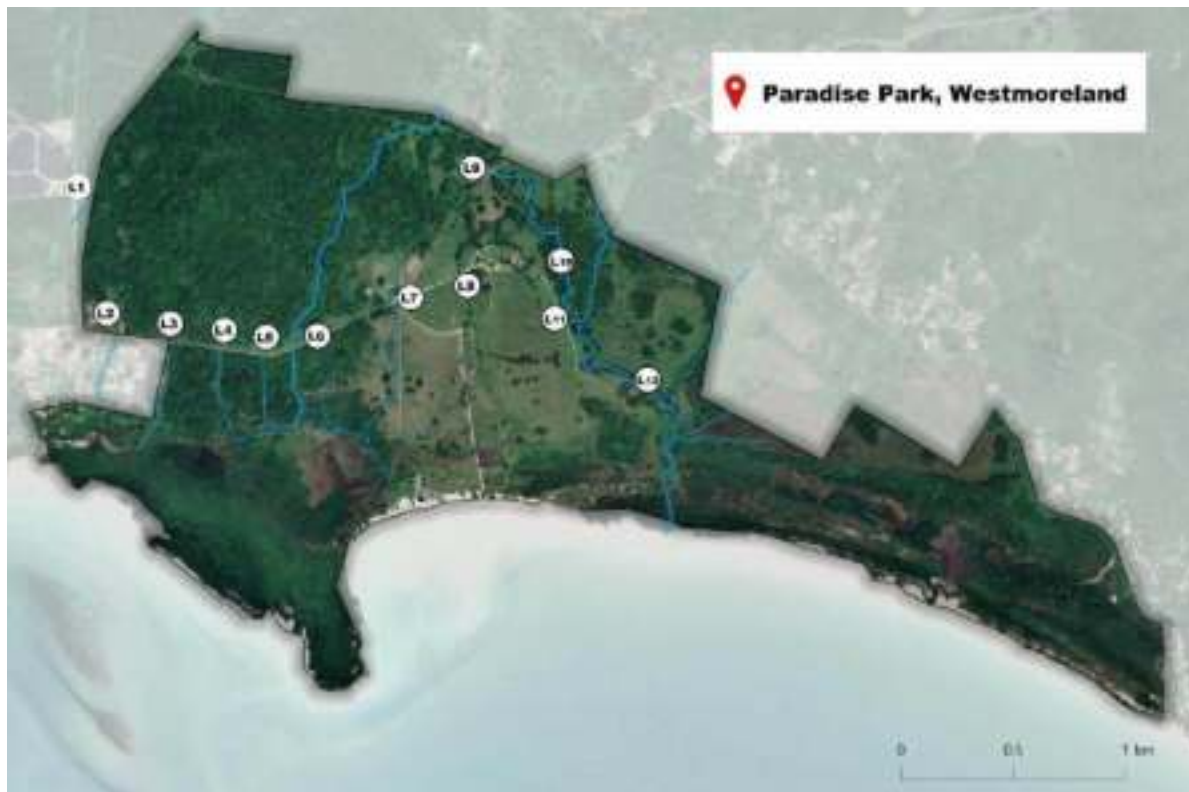
Figure 4-17 Culvert crossing locations assessed in the field

Twelve existing drainage features were assessed in the field (Figure 4-17); the following provides a summary of their key characteristics (Premier Land & Water Development Ltd., 2023):

- L10 & L11: Further investigation of the Murfitts River (Deans Valley River) revealed a continuous, meandering course with high banks (2m on the left bank, 4m on the right). Some sections showed signs of erosion.

- L12: The downstream section of the Murfitts River (Deans Valley River) maintained pristine conditions, with left and right banks approximately 2m above the water surface. This area has an appealing natural aesthetic.

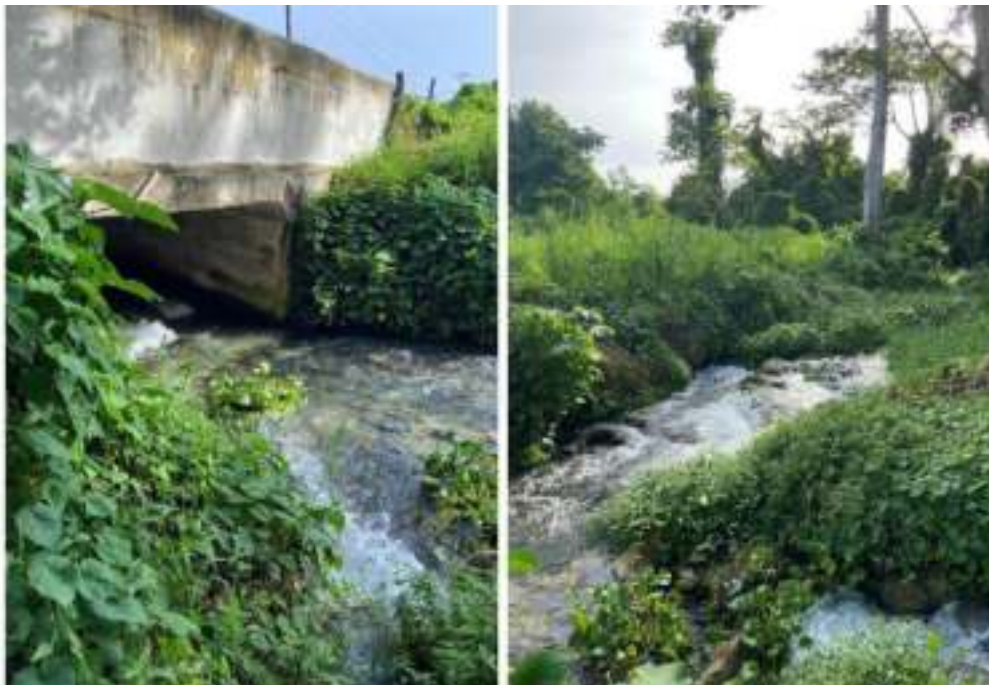
Plate 4-3 Deans Valley River (Murfitts River) upstream and culvert

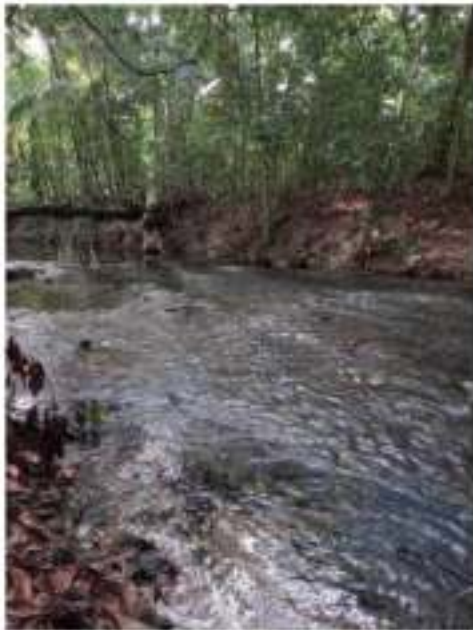
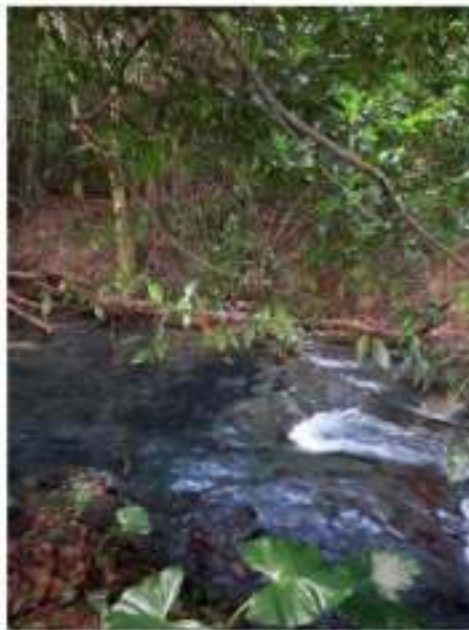
Plate 4-4 Deans Valley River (Murfitts River) bank

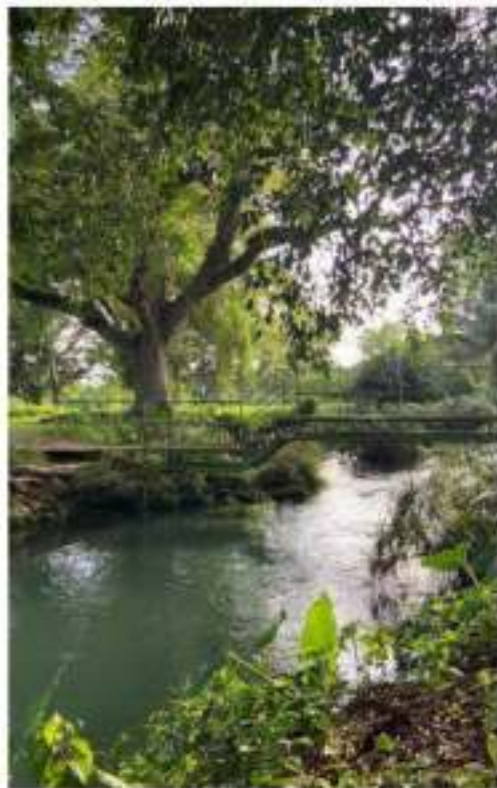
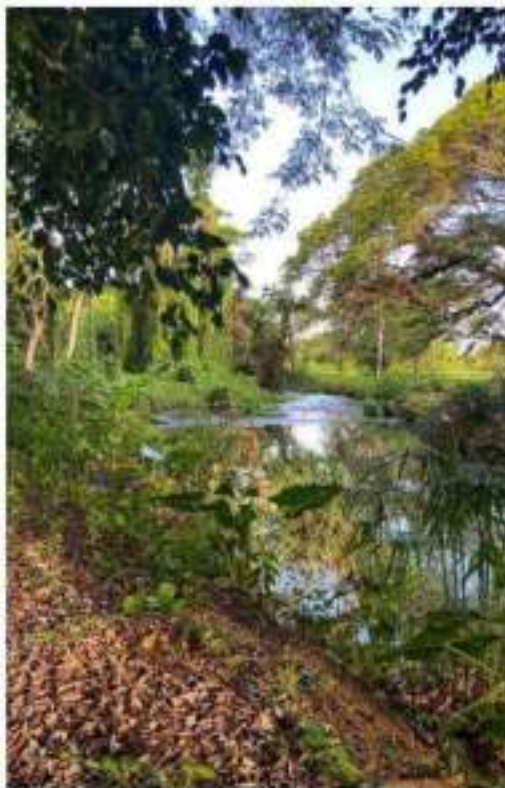
Plate 4-5 Deans Valley River (Murfitts River) downstream

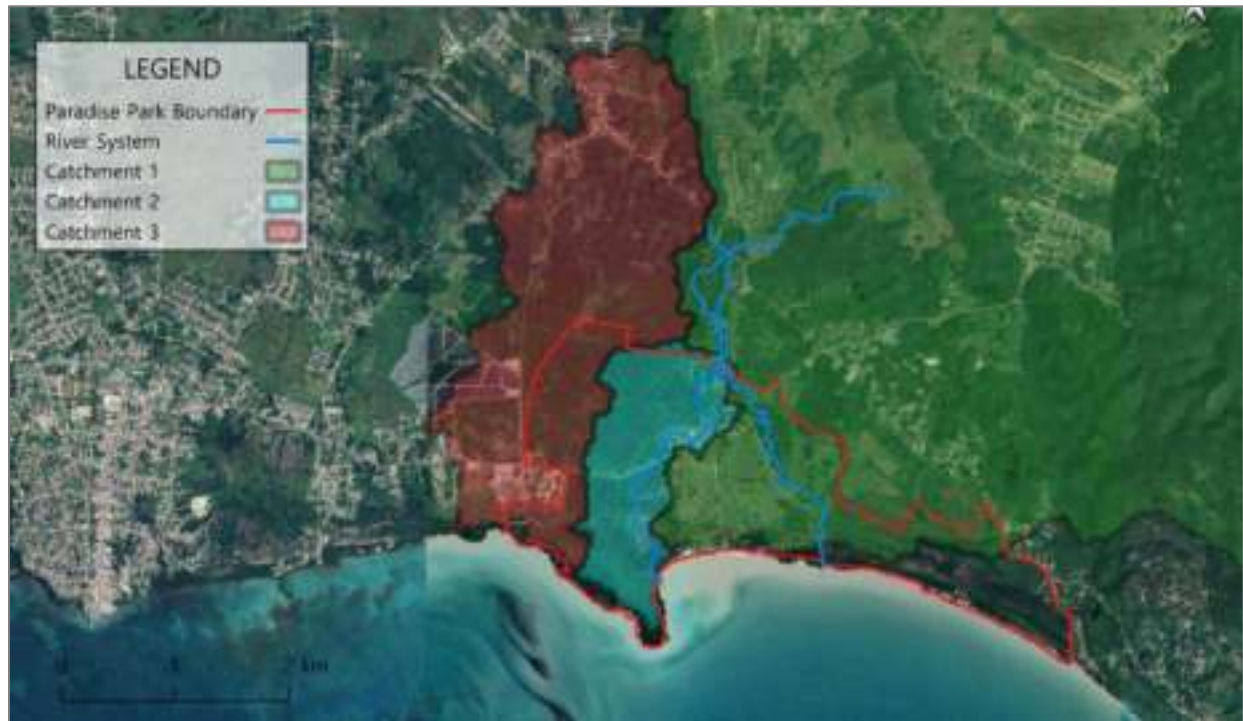
Figure 4-18 Catchment area estimations based on GIS gravity flow delineation

General surface water data and meteorological data close to the site was obtained from the relevant agencies (Water Resources Authority and Meteorological Service of Jamaica). GIS was used to delineate the catchment area of the river within the site (Figure 4-18); it should be noted that due to the relatively flat nature of the site, exact catchment delineations could not be obtained on a gravity flow basis (Premier Land & Water Development Ltd., 2024).

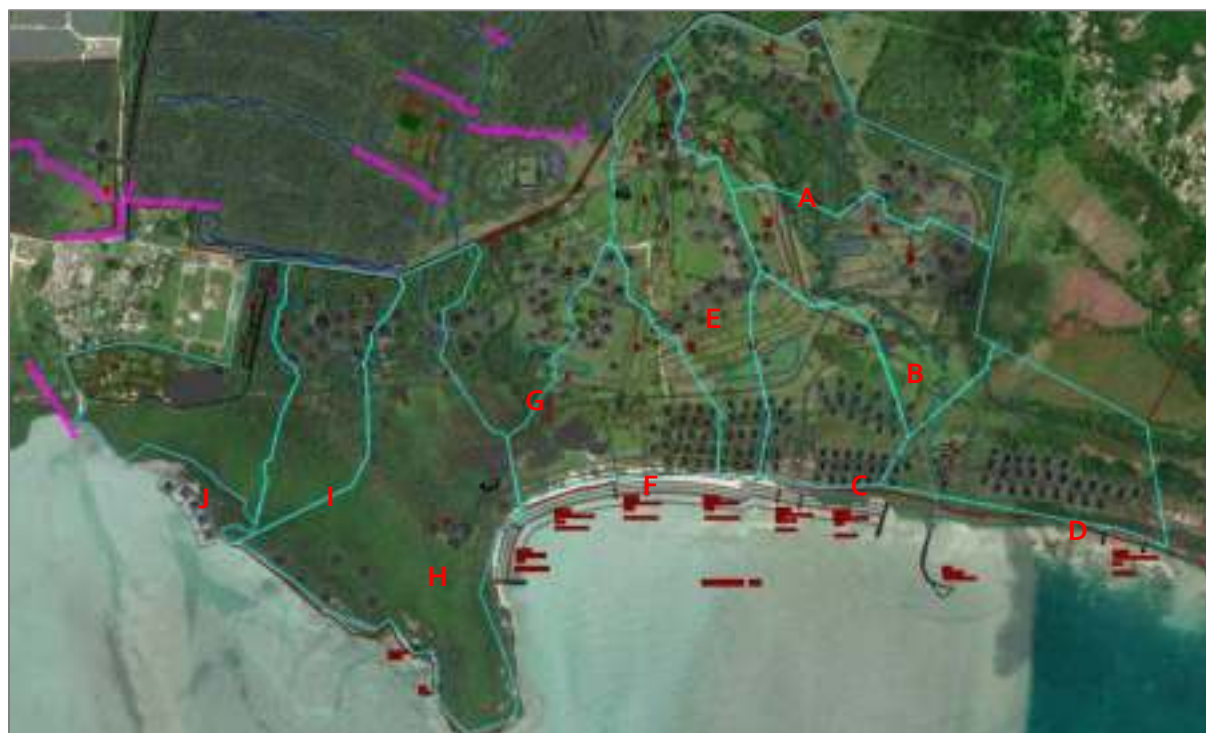
Figure 4-21 Sub catchments used in pre and post construction assessment

The site's sub-catchment characteristics and storage requirements were analysed to assess pre-construction hydrological conditions and plan for effective stormwater management. Sub-catchments were manually determined based upon flow path directions (Figure 4-21). Sub-catchment areas ranged from 24.0 ha (Catchment I) to 61.2 ha (Catchment H), with flow path lengths varying between 675 m (Catchment A) and 1,543 m (Catchment E) (Table 4-3). Slopes were generally uniform at 1–2%, resulting in similar peak times, with time to peak around 12.2 hours across all catchments. The time of concentration ranged from 24 minutes (Catchment A) to 44.8 minutes (Catchment E) (Premier Land & Water Development Ltd., 2024).
