**PROPOSED RESORT  
DEVELOPMENT AT  
PARADISE PARK,  
SMITHFIELD,  
WESTMORELAND**

**ENVIRONMENTAL  
IMPACT  
ASSESSMENT**

**FINAL V. 2**

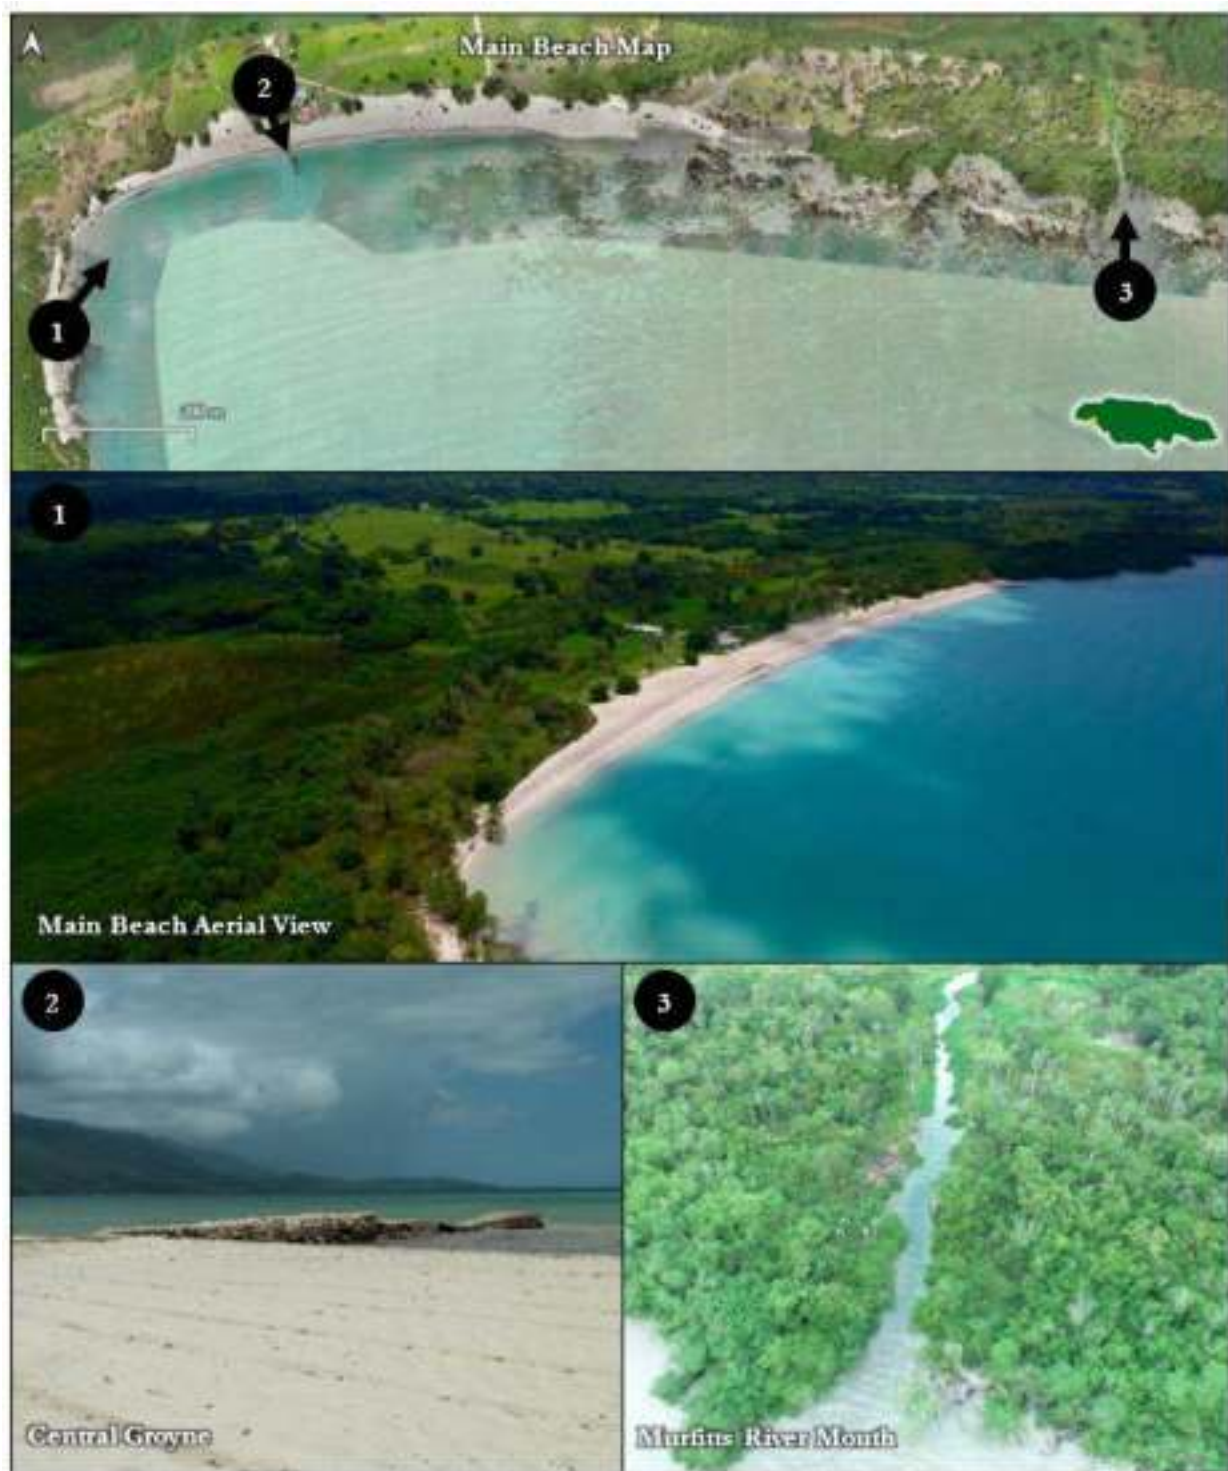
Figure 4-22 Site photos showing the nearshore and features of the existing coastline

The existing beach stretches approximately 1.2 km in length and reaches up to 50 meters wide in certain areas (Smith Warner International Limited, 2025). Two low-crested groynes are currently in place along the shoreline, helping to retain sediment over a 700-meter stretch. The central groyne, which is around 15 years old (Figure 4-22), is showing signs of failure.

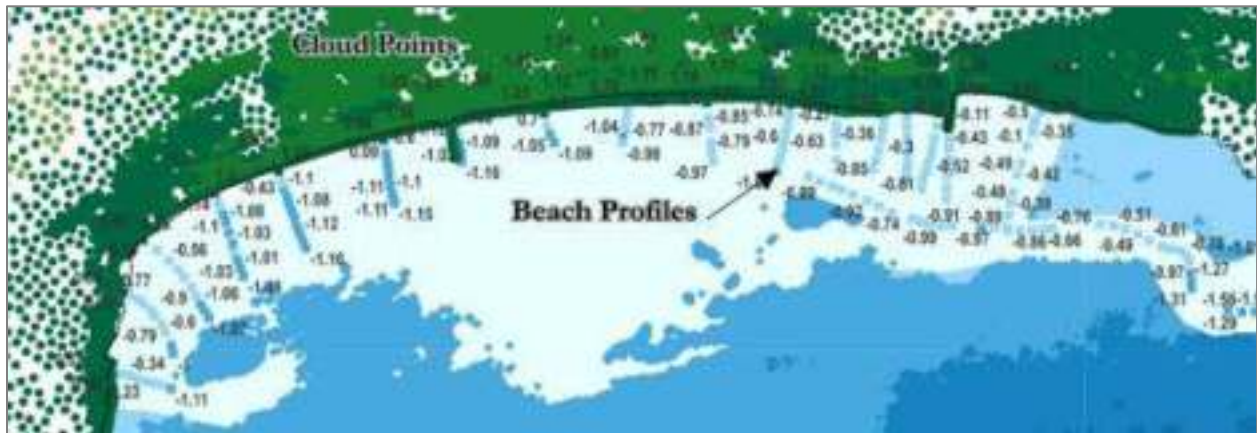
Figure 4-24 Beach profile and EOMAP® bathymetry data

Calculations based on 2022 EOMAP® bathymetry data reveal a seafloor slope of 1(V):200(H) extending 1.5 km to a depth of 7 meters. Beyond this, the slope becomes even gentler, at 1(V):900(H), extending to the 10-meter contour, approximately 3 km offshore. The absence of offshore reefs or shallow platforms suggests a potential vulnerability to wave events (Smith Warner International Limited, 2025).

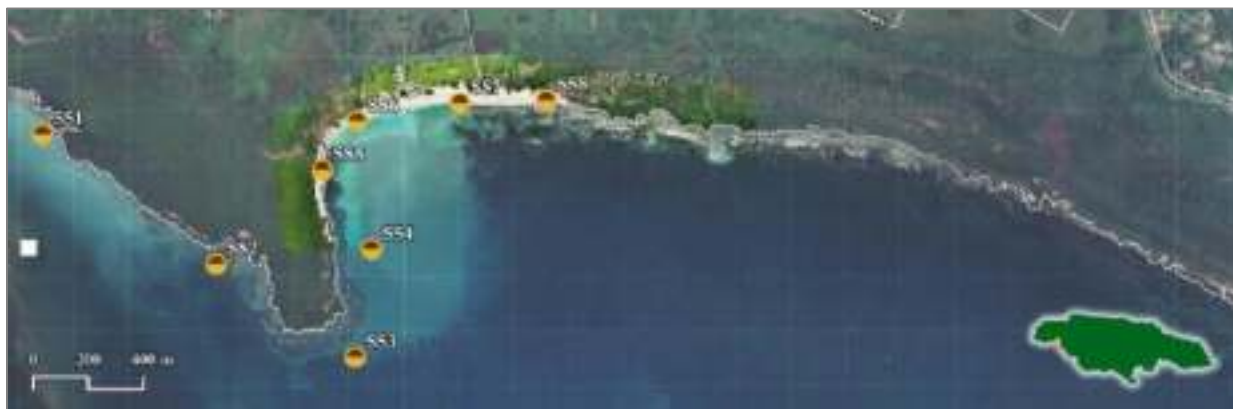
Figure 4-25 Sediment sample and borehole locations

Eight sediment nearshore samples were collected from the site for sediment type classification, four of which were taken from the beach (SS5 to SS8) (Figure 4-25) (Smith Warner International Limited, 2025). Following sample collection, the samples were sent to a geotechnical laboratory, where they were visually inspected, air-dried, and subjected to standard dry sieve analysis to assess grain size distribution and classify the sand (USDA, 1979). Grain size distributions are shown in Figure 4-26, and Table 4-4 shows indicative grain diameters and classifications (BSI, 2018).

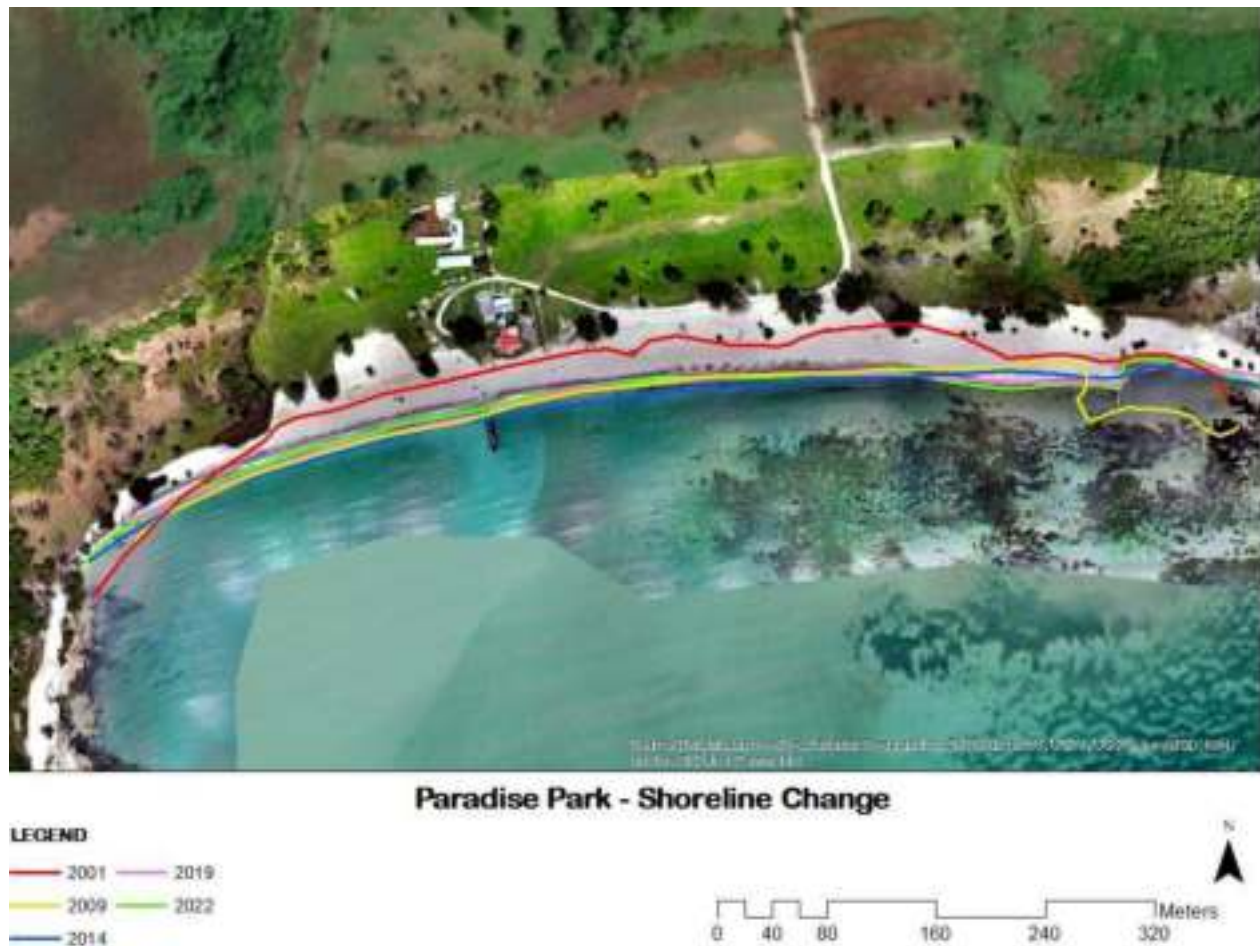
Figure 4-28 Historical shoreline change from 2001 to 2022

Despite the potential for various errors, comparing the variations between images is still considered valuable for quantifying coastal changes in a general sense. From 2001 to 2009, the beach experienced significant accretion in width along the shoreline. Mr. Busha Clarke, a resident of the property, explained that certain storm events played a role in the beach's development during this period. According to NOAA hurricane tracks, several notable hurricanes, including Hurricane Ivan and Hurricane Dean, impacted Jamaica's south coast between 2001 and 2009. These extreme events are believed to have brought non-silty sediment from deeper waters onto the beach. Since 2009, the shoreline has remained relatively stable up to 2025. During a site visit in January 2025, Mr. Clarke confirmed that the beach had shown no signs of change. This suggests that the main beach has been replenished by high-energy hurricane events, as indicated by historical data and interviews with local residents. Since then, the shoreline has remained stable, with day-to-day conditions having minimal impact on its movement.

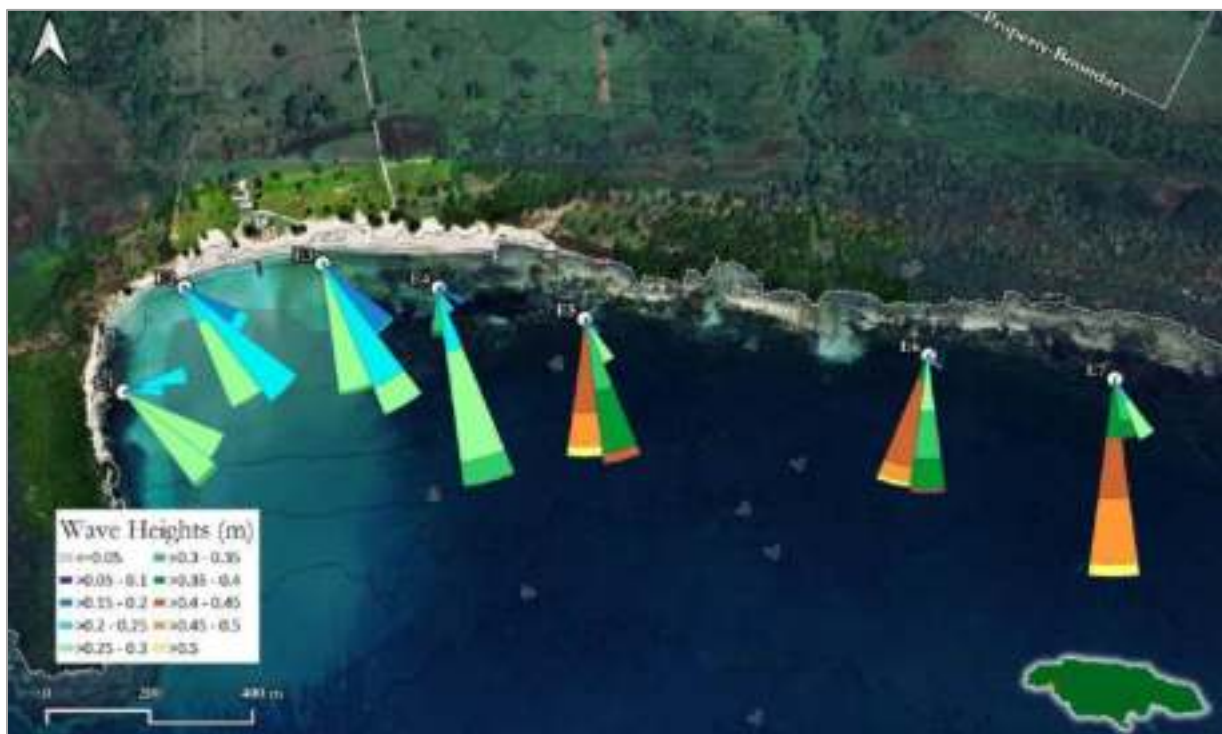
Figure 4-33 Nearshore wave roses along the shoreline of Paradise Park, Westmoreland

The resulting nearshore wave climate data are displayed in Figure 4-33 as wave roses demonstrated the variation of wave heights and directions along the Westmoreland Paradise Park shoreline, wave roses were extracted at depths of around 1m to control any differences linked to wave breaking. E1 to E4, where the existing beach is, the average wave heights at these locations range from very calm to 0.35m annually. E5 to E7, where no existing beach is present, shows much higher wave heights, ranging from an annual average of 0.3 to greater than 0.5m (Smith Warner International Limited, 2025).

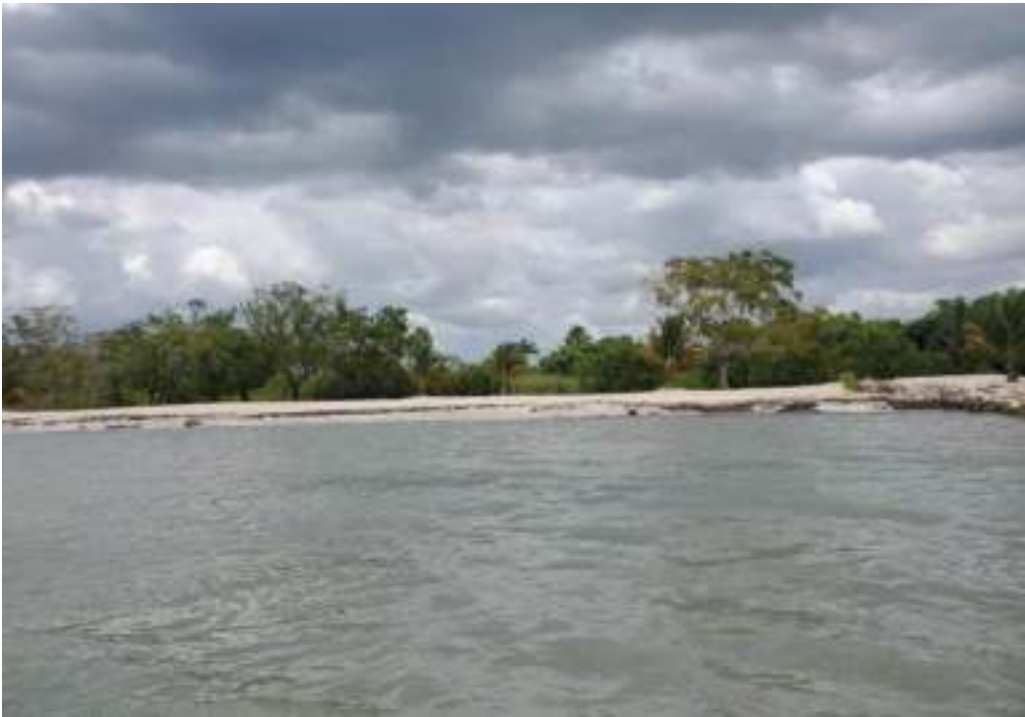
Plate 4-11      Images of Marine water near PP6

Turbidity was low across most stations (Figure 4-77), however some key areas had notable turbidity values. Station PP6 and PP7 were located towards the centre of the project site, this area was noted to have poor circulation and an accumulation of suspended sediment as seen below in Plate 4-11. High turbidity at Station PP14 was most likely due to the river outflow while Station PP27 which had the highest turbidity value was shallow with a soft silty and muddy substrate, where sediments can be easily resuspended by wave action and boat activity during sampling. Figure 4-77 shows the average turbidity values for the sixteen marine stations sampled.

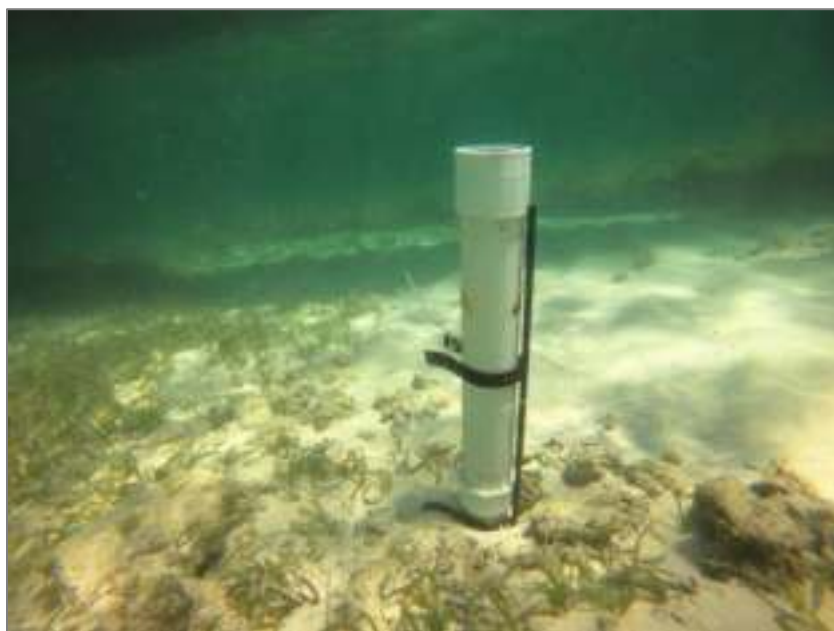
Plate 4-12 Example of sediment trap deployed

Baseline sedimentation data was collected using sediment traps, approximately 21.4" (54.3 cm) long with an internal diameter of 3" (7.6 cm) (Plate 4-12). A total of eight (8) sediment traps were deployed in and around the project area (

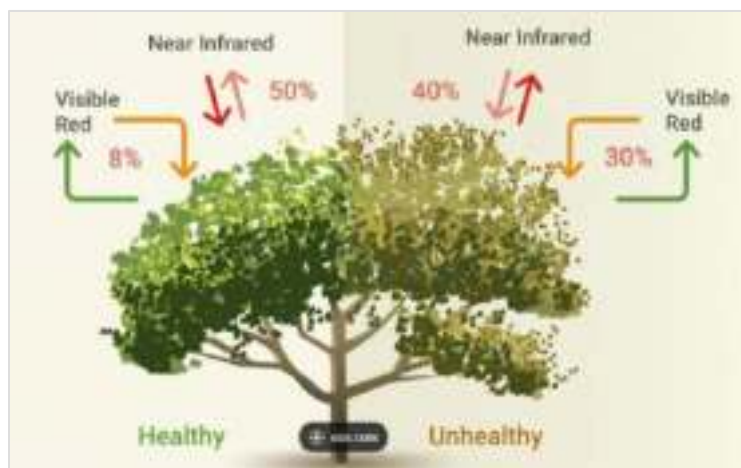
Figure 4-123 Illustration of absorption and reflectance of visible red and NIR light by healthy and unhealthy plants

Chlorophyll reflects near-infrared (NIR) light (700 to 1100 nm), however absorbs visible light (400 to 700 nm) for use in photosynthesis. This means that high photosynthetic activity, commonly associated with dense healthy vegetation, will have less reflectance in the red band and higher reflectance in the near-infrared band (Figure 4-123). Resulting NDVI values range between -1 and 1. If the result yields high NDVI values, this signifies more or healthier vegetation, and vice versa with low NDVI values, less or no vegetation. NDVI may also give indications for other types of land cover and Table 4-25 provides the classification utilised in this assessment.

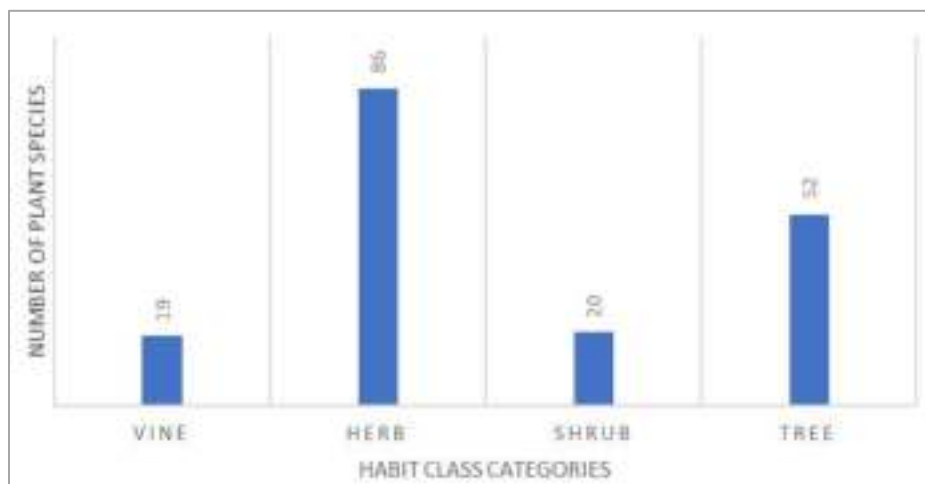
Figure 4-126 Summary chart of zone 1 plant species habit class

The majority of the plant species recorded in Zone 1 were herbs (86), followed by trees (52) the least represented Habit Classes in Zone 1 were shrubs (20) and vines (19). Commonly occurring shrubs across Zone 1 included: Duggy Gun (*Ruellia tuberosa*), Scratch Coco (*Alocasia macrorrhizos*), Jack-in-the bush (*Chromolaena odorata*). Some of the trees most frequently observed during the assessment of this zone included: Pink poui (*Tabebuia angustata*), Logwood (*Haematoxylum campechianum*), Guango (*Samanea saman*), Bastard Cedar (*Guazuma ulmifolia*).

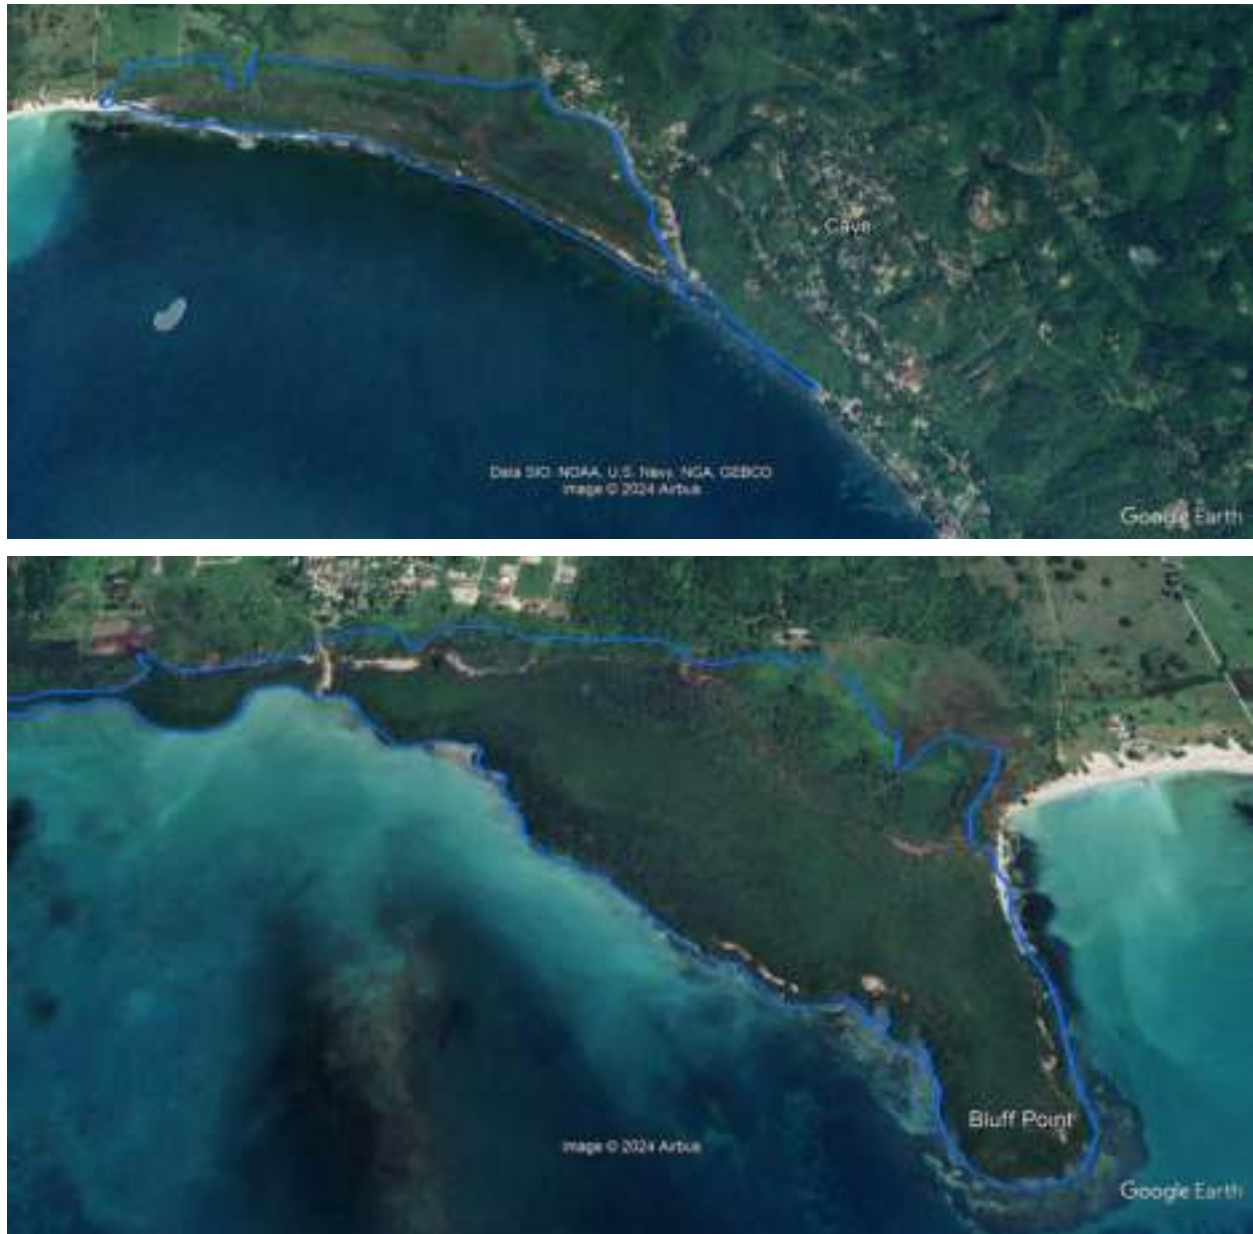
Figure 4-155 Paradise East and Cave Forested Wetlands (top) and Paradise West to Petersfield Forested Wetlands (bottom) (Forest Department 2021)

The proposed development site has been identified as part of a forested wetland system in the national inventory of wetlands and the National Mangrove and Swamp Forest Management Plan (NMSFMP), which was conducted between 2021 and 2023 (Forestry Department, 2022). While the report categorizes the property into distinct zones, the NMSFMP documentation refers to the "Paradise" site as consisting of two separate areas: East (149.1 ha) and West (117 ha). It is important to note that these areas represent the broader connected wetland systems, which extend beyond the current study site and the proposed development area (Figure 4-155).

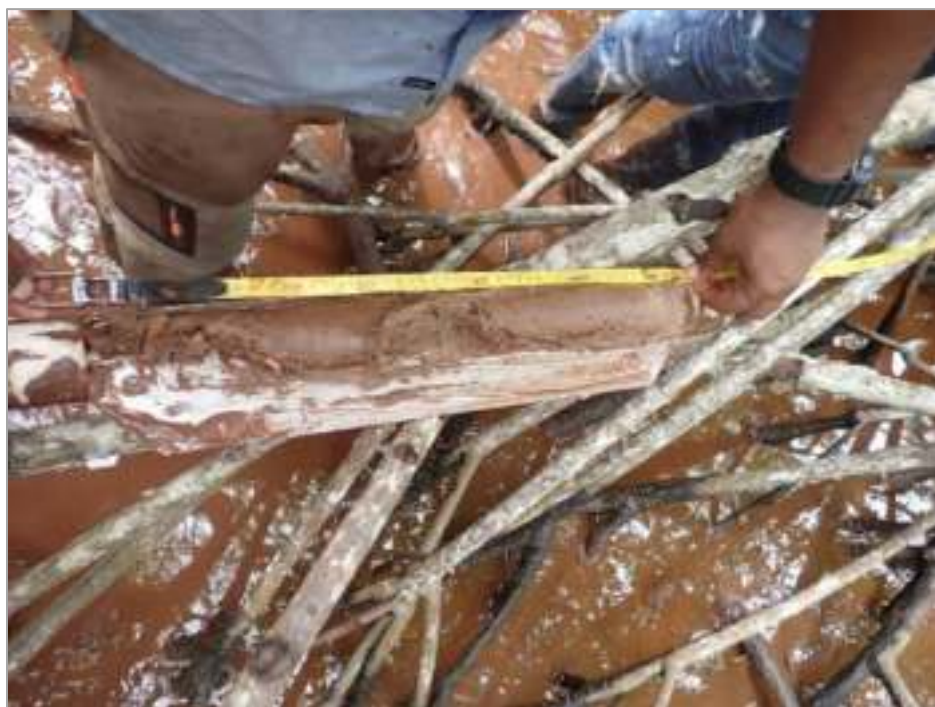
Plate 4-30 Mangrove soil core sample

A 1.7 m rebar was used at each location to determine the maximum depth of soil within each area. Cores were collected using a 5 cm diameter semi-cylindrical Russian peat corer with extensions (see Plate 2-1 below). Each core was further subdivided into 0-15 cm, 15-30 cm, 30-50cm and 50-100 cm subsections as per highly aggregated sampling scheme described by Howard et al. (2014). Each subsection was packed in sampling bags, preserved in a cooler and stored at 4°C in a refrigerator until processed.

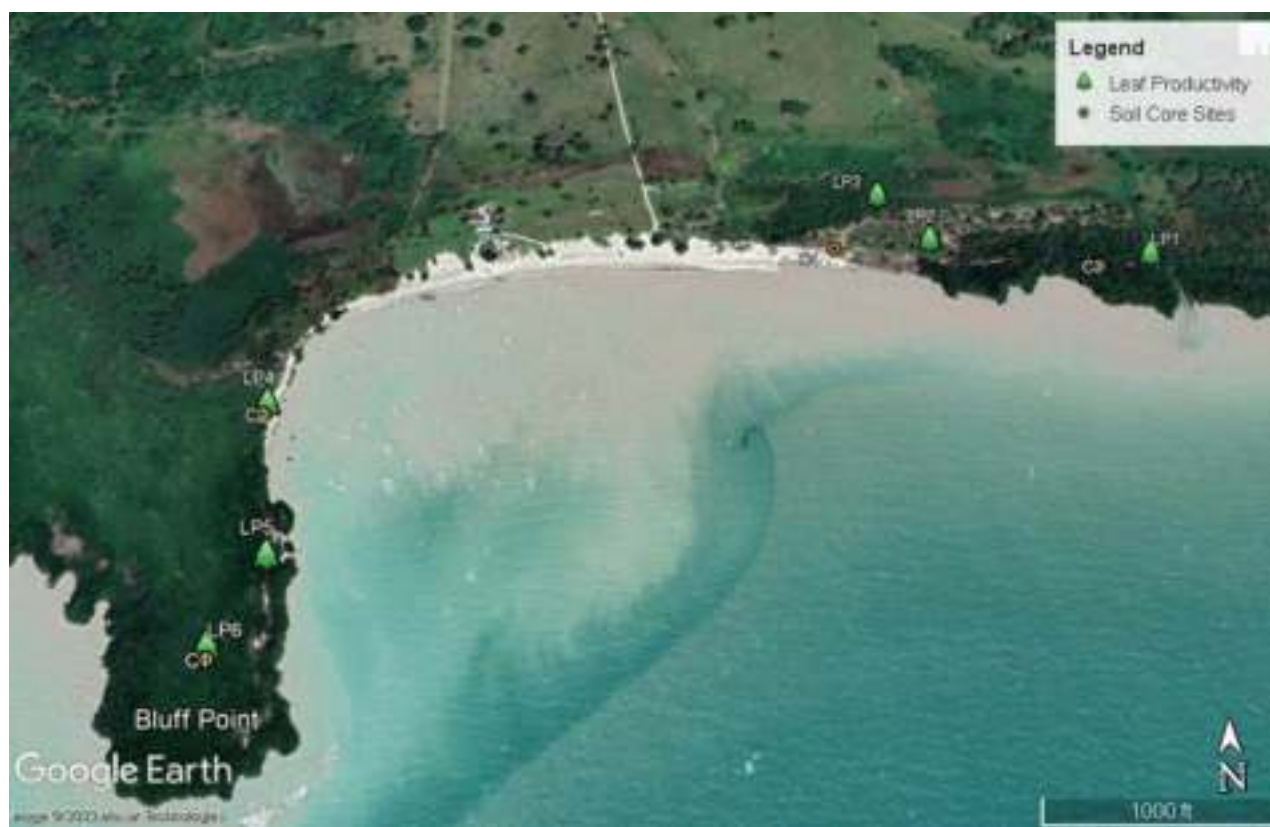
Figure 4-158 Map of wetland leaf productivity and soil core sample sites

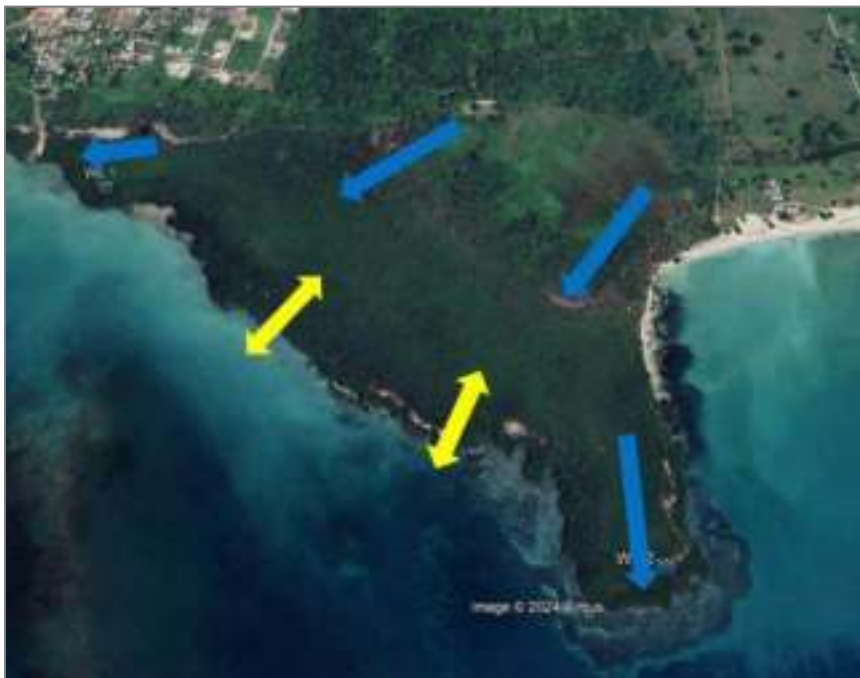
Figure 4-164 Visible hydrology observations for the Western property.

Q2 with a salinity of 7ppt and lower water temperatures in zone 1 was likely influenced by the observed outflow point in that area. The visible hydrology walk-through by the team supports this data as the team observed active outflows in the Q2 area on one occasion. As indicated in the visible hydrology map below ( Figure 4-164), the entire Eastern edge of Zone 1 is a key hydrological feature of the property. Water

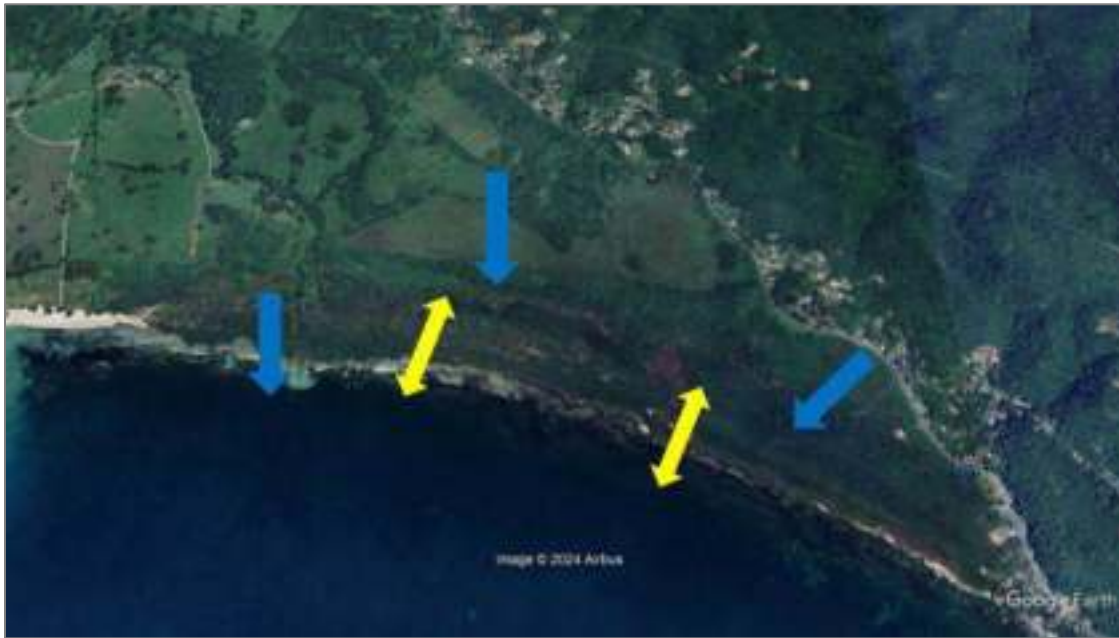
Figure 4-165 Observed visible hydrology for the Eastern wetlands of the property.

The Eastern wetlands (zone 3) showed more defined outflow points via streams and a storm drain near the cave community. The Cave storm drain does not empty directly into the sea however, but meanders through the mangrove forest and may have slow release via tidal movement. This fresh water originated from the herbaceous wetlands between the highway and the mangroves. The transition zone between these herbaceous plants and pure mangrove stands is indicated by forested wetlands. The mangrove zone is indicative of the highest tidal reaches, where mangrove plants out-compete these other species.

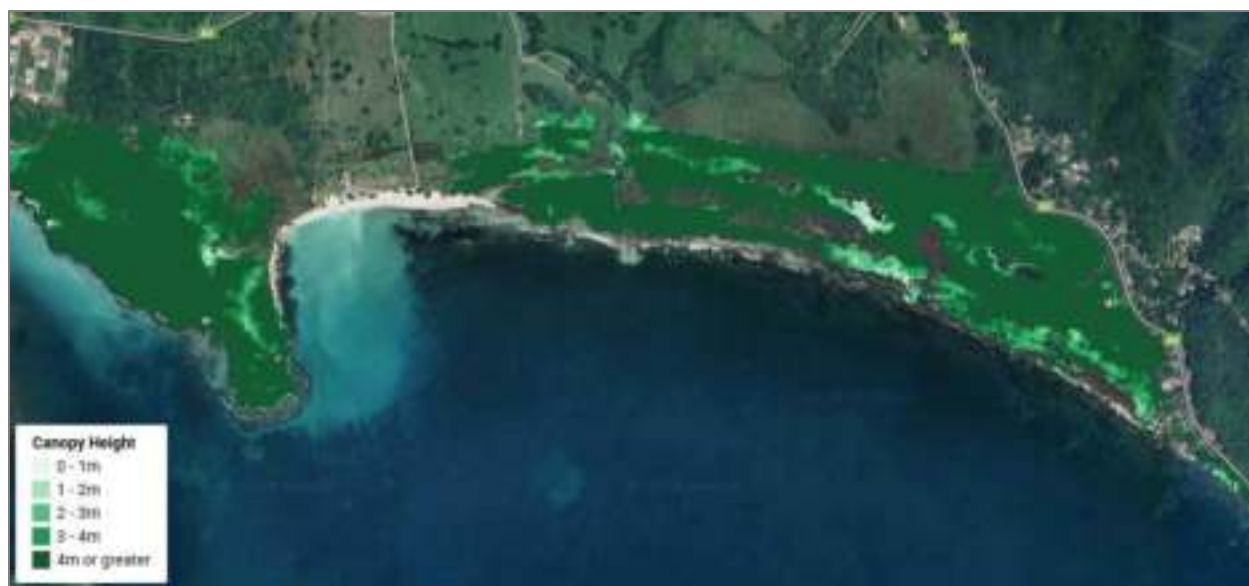
Figure 4-166 TDX canopy height

Within the project area, canopy heights are typically over 4m, with some areas showing heights below this (Figure 4-166).

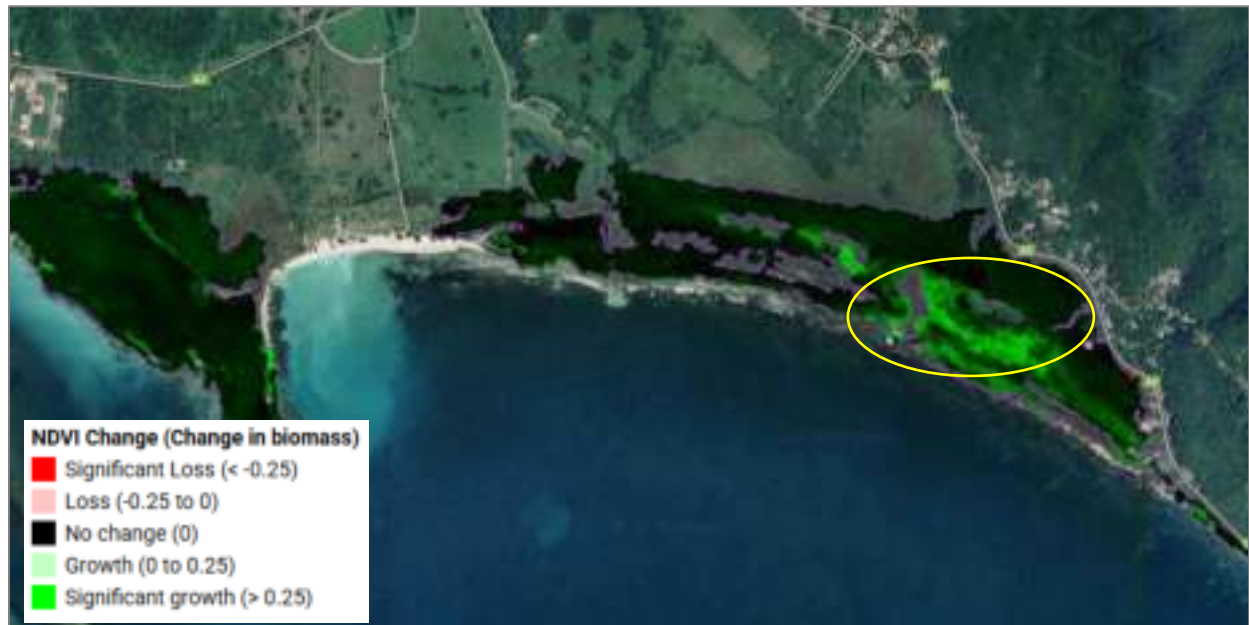
Figure 4-167 NDVI change in mangrove biomass between 2017 and 2024.

Field observations and visual historical image analysis revealed the temporal presence of mudflats in the project area. This finding is supported by significant changes in mangrove biomass between 2017 and 2024 in the eastern wetlands (The Nature Conservancy, 2024), highlighted in yellow in Figure 4-167. In 2017, the area defined as mudflats, with low biomass, was expansive, but by 2023, it had shrunk as mangroves grew (Table 4-37). The observed changes are likely driven by hydrological inputs, in contrast to the small area of significant biomass loss near the main road to the east, which is likely caused by anthropogenic factors. Overall, the wetland and mudflat habitats in the project area exhibit notable temporal changes as demonstrated by biomass variations over the years (Figure 4-168), and these changes must be considered in any restorative or ecological restoration programmes.

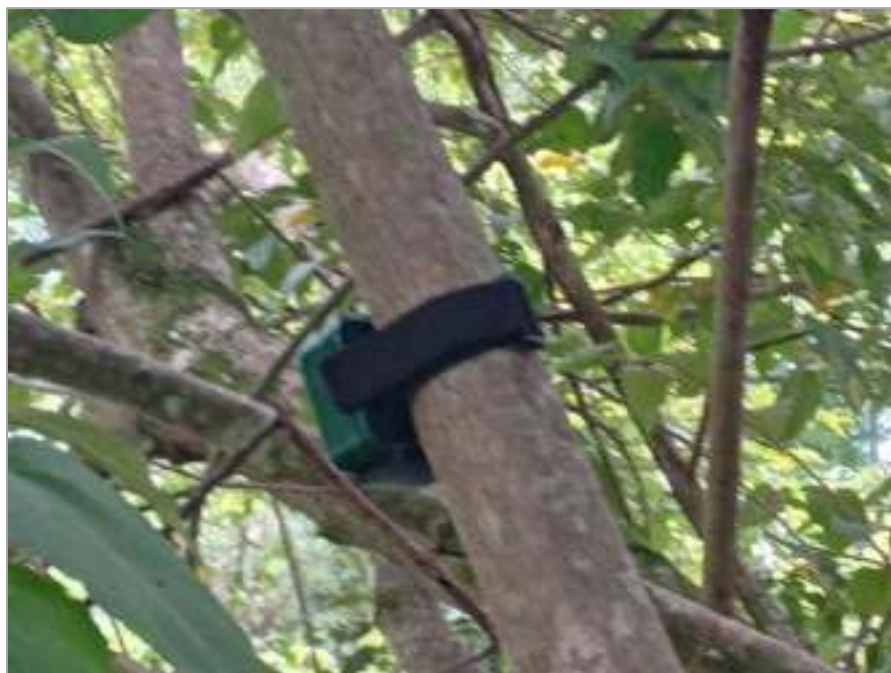
Plate 4-40 An AudioMoth device deployed in the field

A total of 10 AudioMoth® acoustic recorders were deployed at random sample sites throughout the project area (Figure 4-169). The AudioMoth detectors were configured to start recording from 18:30 to 06:00 for 1 night. The sample rate was 384 kHz, and the gain was set at medium. The sleep duration was 5 seconds, and the recording duration was for 5 seconds.

The devices were deployed at least 3 m above the ground, primarily on trees and buildings where possible. The Kaleidoscope Pro® software was used to process and ID the bat calls from all acoustic devices. Please note that the software can only auto-ID 10 of Jamaica's 21 species of bats. The other species were identified using a call library from Windsor Research Centre and internet resources.

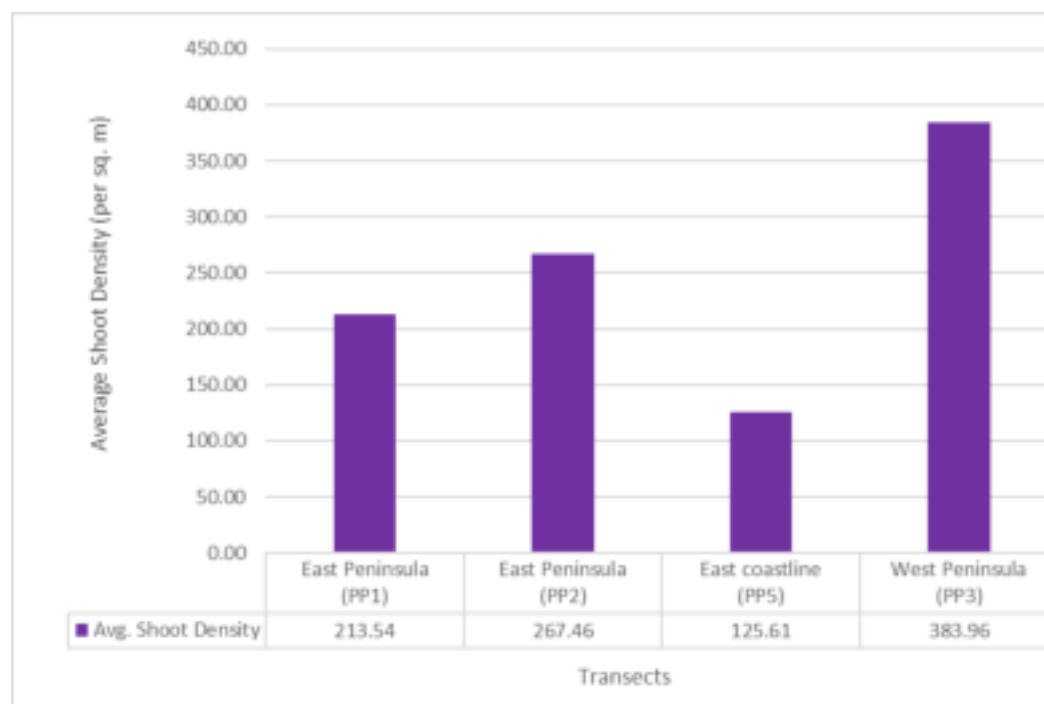
Figure 4-188 Average Shoot Density for *Thalassia* across the study area

Figure 4-188 shows the average shoot density of minimal spatial variation across the study area. The highest density was observed at the West Peninsula (PP3) with 383.96 shoots per sq.m, located outside the sanctuary near a healthy mangrove system that may provide nutrient-rich runoff. Within the sanctuary, the East Peninsula transects (PP1 and PP2) had densities of 213.54 and 267.46 shoots per sq m, respectively, while the East Coastline (PP5) exhibited the lowest density at 125.61 shoots per sq m. These relatively small differences suggest that shoot density is generally consistent across the area, though proximity to mangroves and distance from the shoreline may slightly influence local variations. Variations in seagrass species composition were influenced by transect location. *Halodule* was more common in nearshore areas, while *Thalassia* dominated further offshore. This pattern was consistent across the study area.

Overall, the *Thalassia* beds showed minimal spatial variation across the survey area for leaf blade length, shoot density, and percentage cover. The highest values for all metrics were consistently observed at the West Peninsula (PP3), likely influenced by nutrient inputs from nearby mangroves. While slight differences were noted, the beds within the sanctuary displayed generally consistent health, suggesting stable environmental conditions and the importance of surrounding ecosystems in supporting seagrass vitality. Seagrass productivity values varied between 0.041 g/m<sup>2-14</sup> at PPC3, PPC5 and PPC7 and 0.074 g/m<sup>2-14</sup> at PPC2. Soil carbon values were highest along the west peninsula (160.28 MgC) and east coastline (150.40 MgC) and lowest along the east peninsula (80.68 MgC).

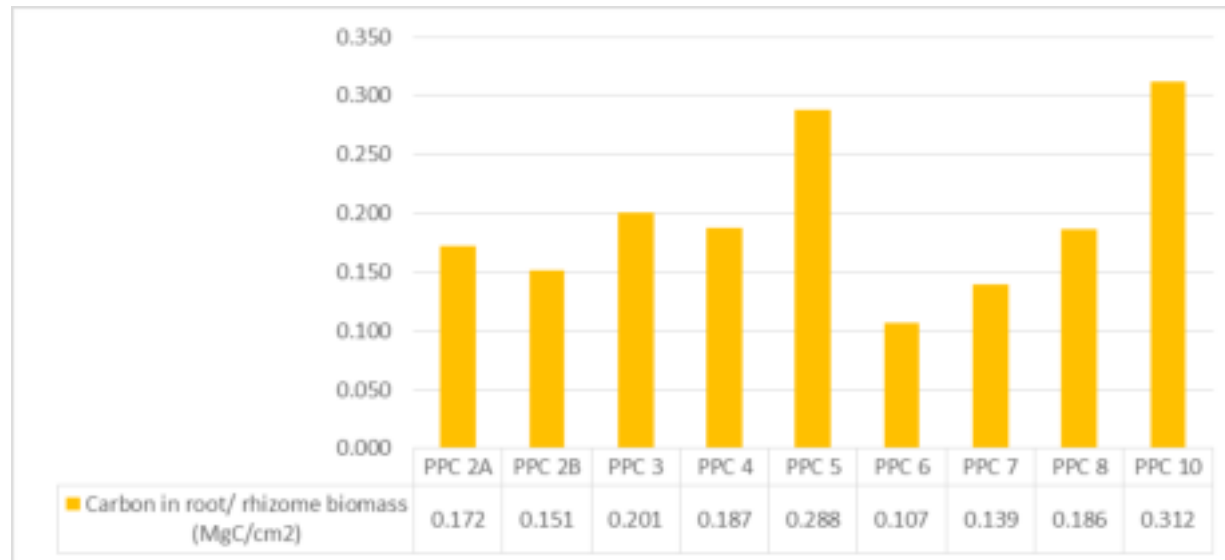
Figure 4-197 Carbon in root/rhizome biomass (MgC/cm²) per site of samples taken at Paradise Park.

Along the eastern peninsula, root carbon was highest at PPC 5 and lowest at PPC 6 while along the east coastline, carbon values were highest PPC 10 and lowest at PPC 7 (Figure 4-197).

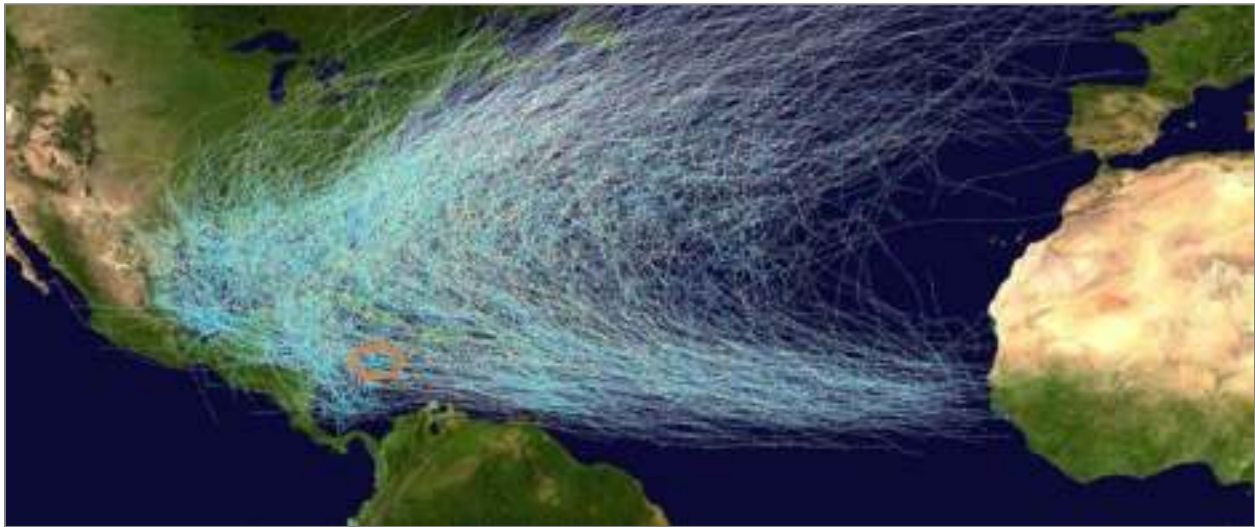
Figure 4-208 Atlantic hurricane tracks since 1851, the sweeping shape of which is commonly called 'Hurricane Alley' (an orange oval highlights Jamaica's location)

The Caribbean region is vulnerable to tropical storms and hurricanes yearly from June to November. These storms can cause dramatic and abrupt changes to the coastline. Jamaica lies in 'Hurricane Alley'—an area of water in the Atlantic Ocean where hurricanes typically form because of the warmer sea surface temperatures. Figure 4-208 shows typical paths of hurricanes in the North Atlantic basin, which tend to form between latitudes 5°N and 25°N off the west coast of Africa and then track across the Atlantic Ocean. Those formed at the lower latitudes are usually pushed on a westerly track by the northeast trade winds, whereas those of the higher latitudes track more to the north and north-west (Smith Warner International Limited, 2025).

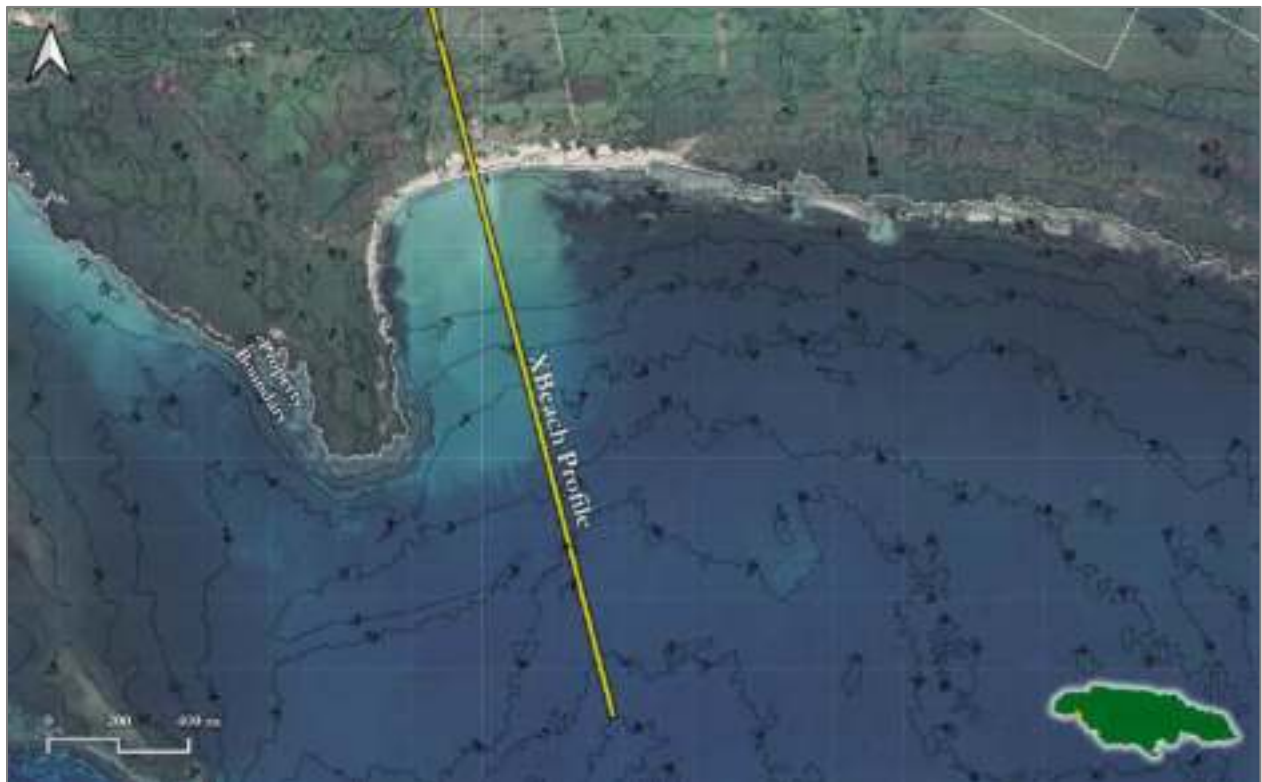
Figure 4-215 XBeach profiles assessed wave run-up on the Paradise Park, Westmoreland property.

XBeach (Roelvink, 2009) was applied in a one-dimensional format to simulate the storm-induced water level changes for the design events detailed in the prior sections. One profile was taken within the boundaries of the site (Figure 4-215), which would be used to predict levels for the entire property. The profile was extracted using a simple routine in GIS software that merged the topographic data, beach profiles, bathymetric tracks and EOMAP satellite-derived bathymetry. The data was interpolated to provide a one-dimensional profile that extends perpendicularly from the shoreline (and runs parallel to the bathymetry contours) to about the 8m depth contour along the project site and input to the XBeach model. The profile does not consider the buildings along the property and, as such, may be considered as a worst-case scenario (Smith Warner International Limited, 2025).

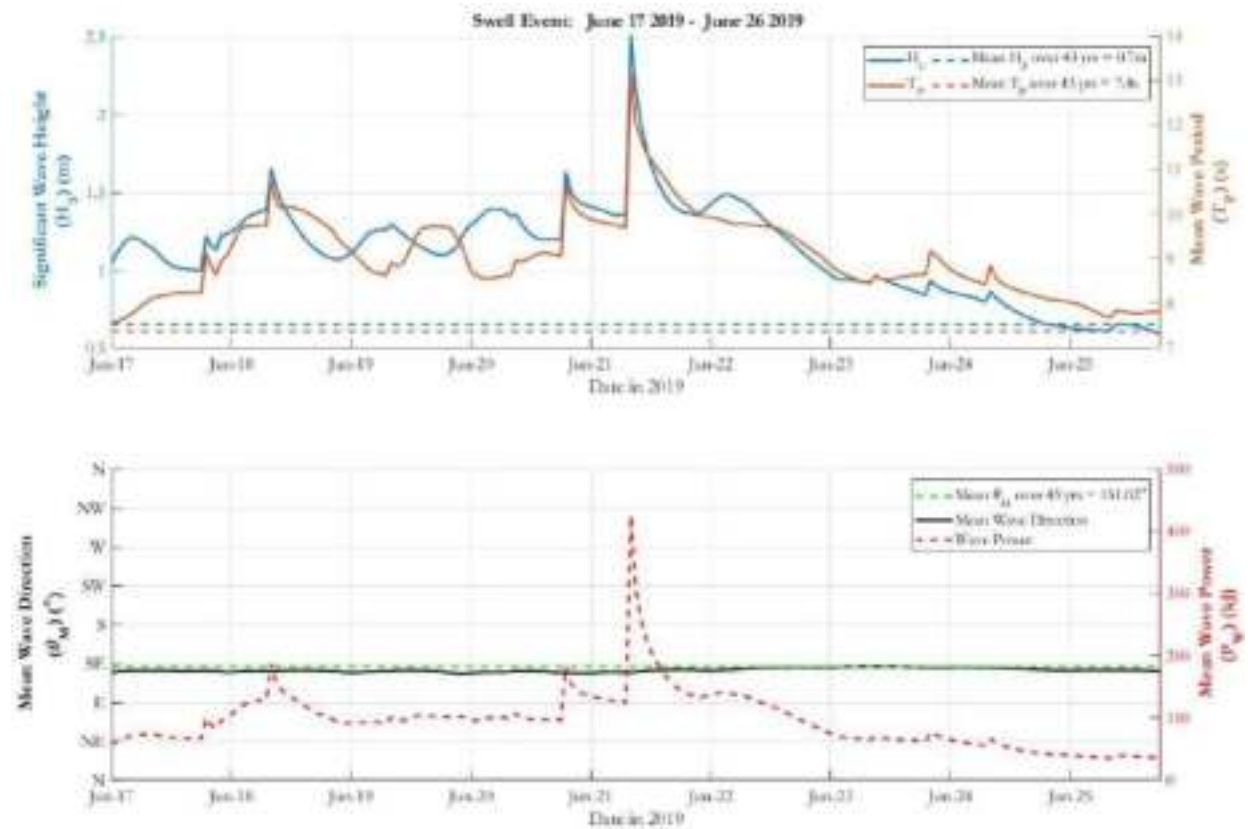
Figure 4-217 Swell event of June 17 to 26, 2019 wave conditions.

An energetic wave event was simulated to assess the impacts associated with swells. This process began by filtering the ERA5 database to produce a list of swell events. The results showed that one of the top events occurred from the 17<sup>th</sup> to the 26<sup>th</sup> of June in 2019. This event had wave heights between 0.6m and 2.5m offshore, peak wave periods of about 13s and approached from the southeast for most of the event. The time series of the event has been graphed in Figure 4-217. These wave conditions were run across the model domain, including the bathymetric information offshore of the Westmoreland parish. The model included hydrodynamic (water surface), waves and sediment transport modules. The results of the simulation at the peak timestep are shown in Figure 4-218 (currents), Figure 4-219 (waves), and Figure 4-220 (bed level change) (Smith Warner International Limited, 2025).
