**PROPOSED RESORT  
DEVELOPMENT AT  
PARADISE PARK,  
SMITHFIELD,  
WESTMORELAND**

**ENVIRONMENTAL  
IMPACT  
ASSESSMENT**

**FINAL V. 2**

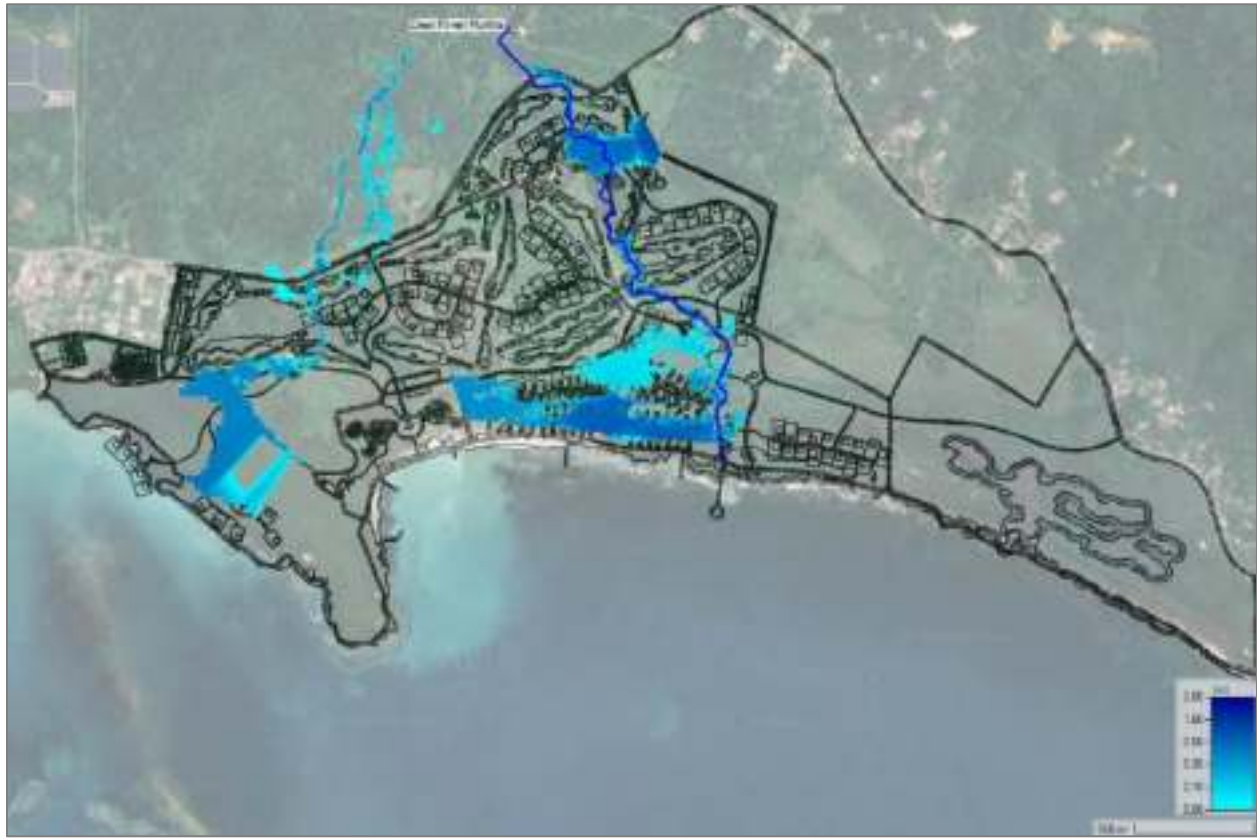
Figure 4-224 Flood inundation map for the 1–100-year storm event at Paradise Park in the existing condition.

The findings indicated that the highest flood depth reached approximately 1.6 meters. Wetland areas and depressions along the river reach were identified as the locations most likely to flood. Specifically, the flood inundation model indicates that there are areas adjacent to the Dean Valley River which experiences inundation levels between 0.1m to approximately 0.47m in the particularly low-lying areas (Figure 4-224).

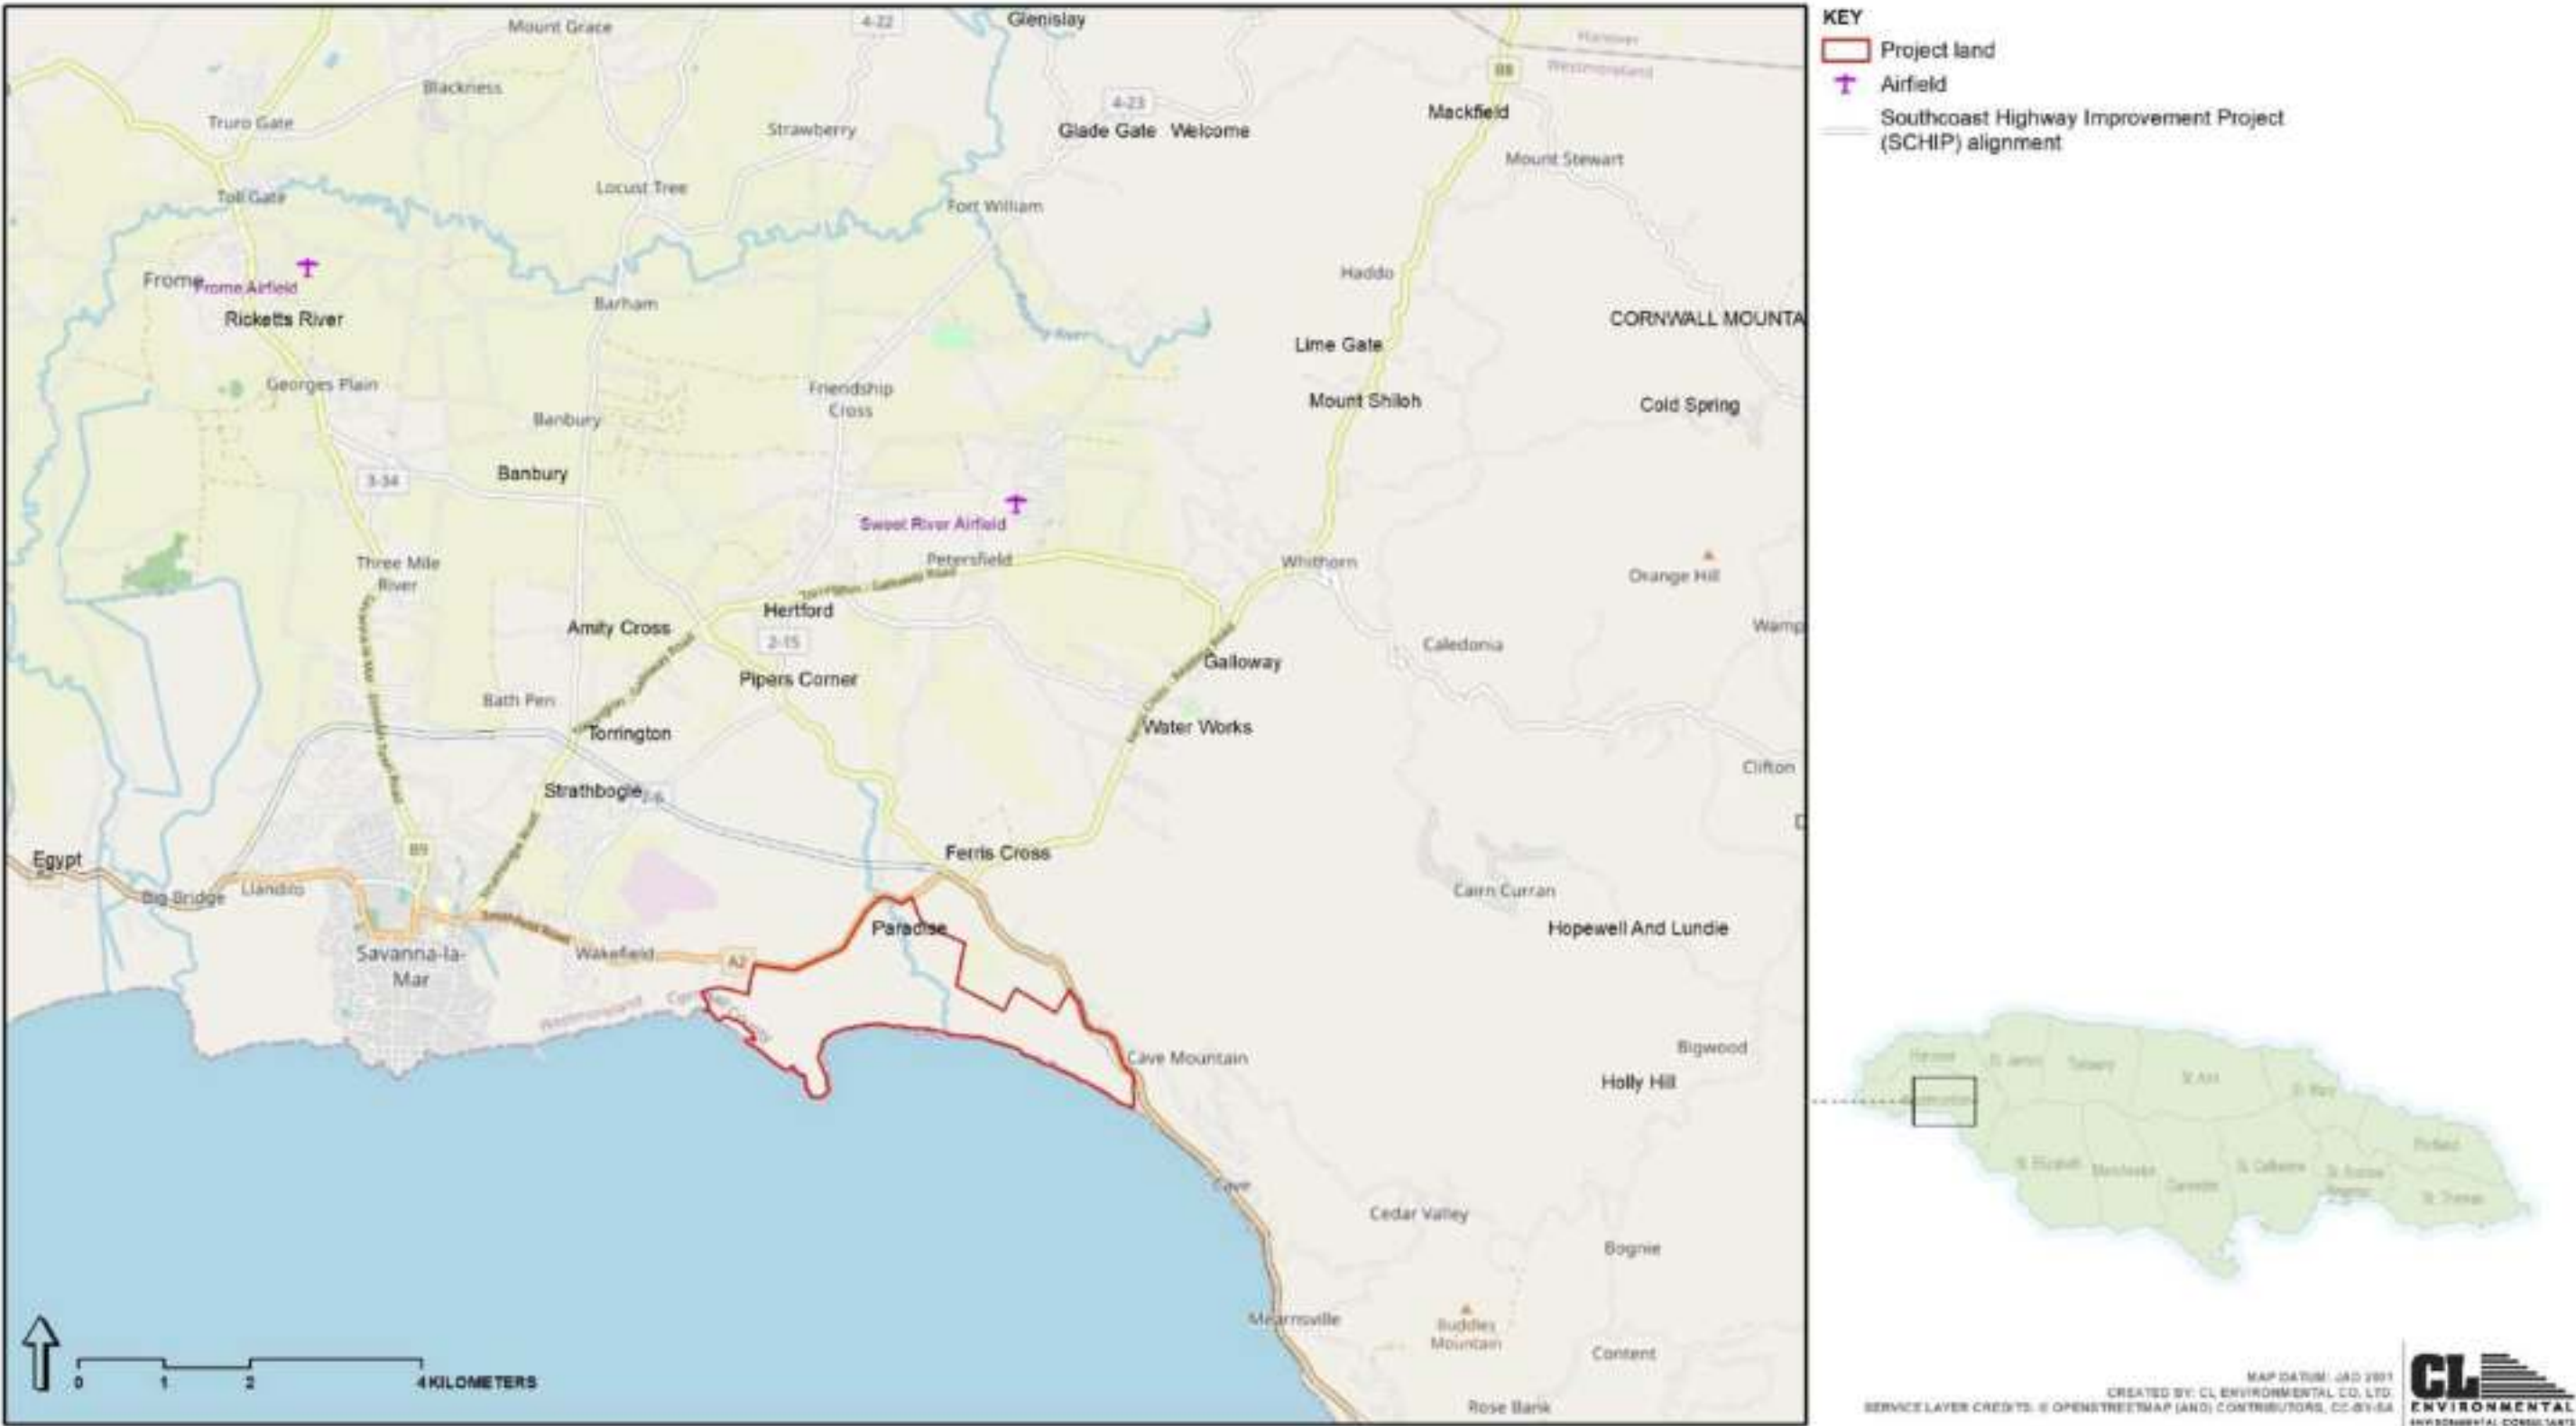
Figure 4-240 Road network in the study area

The primary access to the property is a single entrance located on the existing Savanna-la-mar main road (A2 highway), approximately 2.5 km from the town of Savanna-la-mar. The A2 highway, part of the primary road network that encircles the island, runs parallel to the northwestern and eastern boundaries of the project land. The proposed alignment for the Southcoast Highway Improvement Project (SCHIP) also follows the existing A2 highway along the eastern boundary of the project area (Figure 4-240).

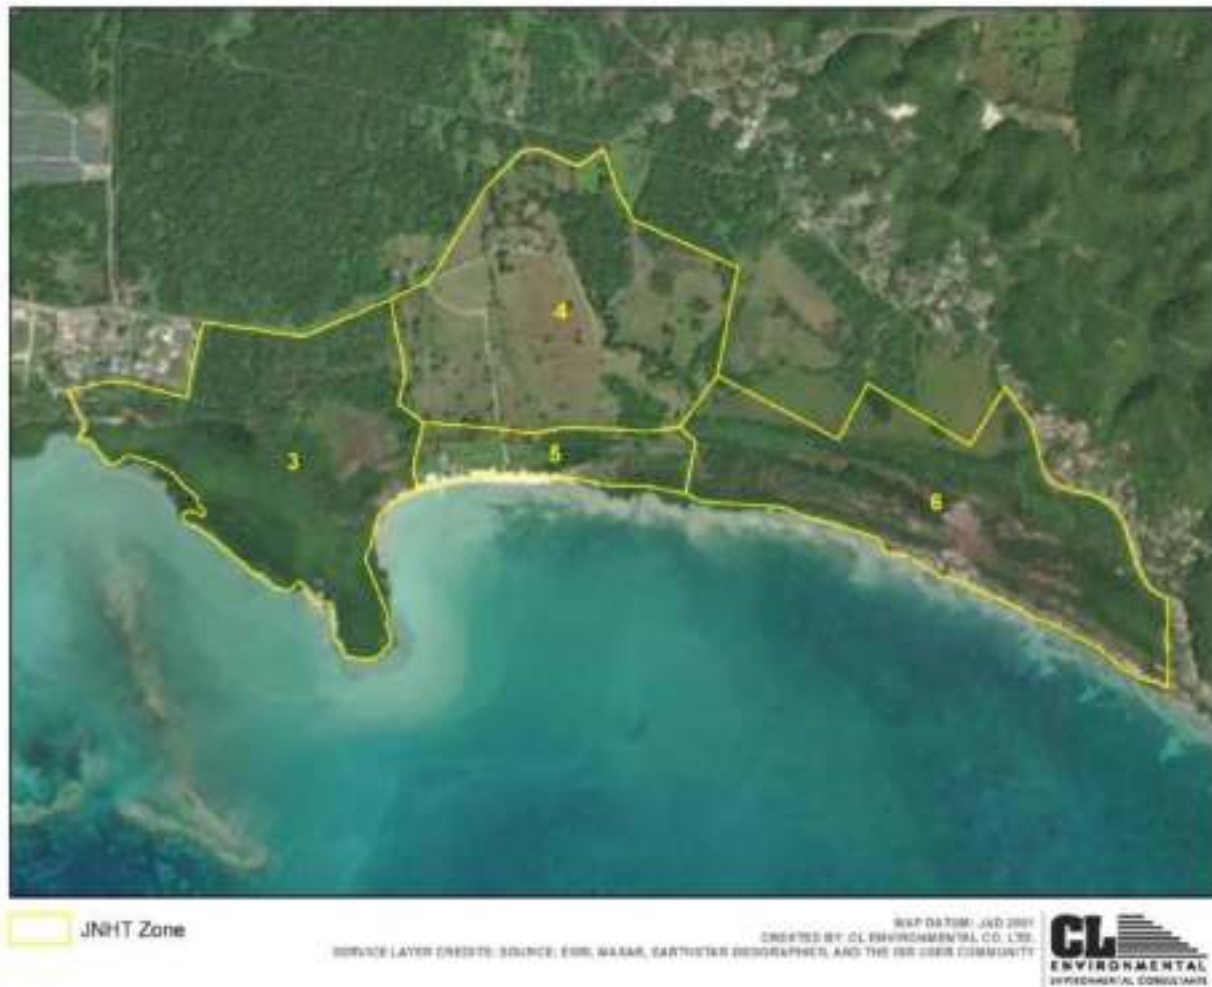
Figure 4-256 JNHT survey zones

A site survey was also conducted from July 23 to July 28, 2023, which included an archaeological field walk and windshield survey in the land parcels, referred to as Zones, within the project area (Figure 4-256). Artefact samples were collected and analysed, and cultural heritage contexts were interpreted. Significant cultural assets that could potentially be affected by the proposed development were recorded during the survey (Jamaica National Heritage Trust, 2023).

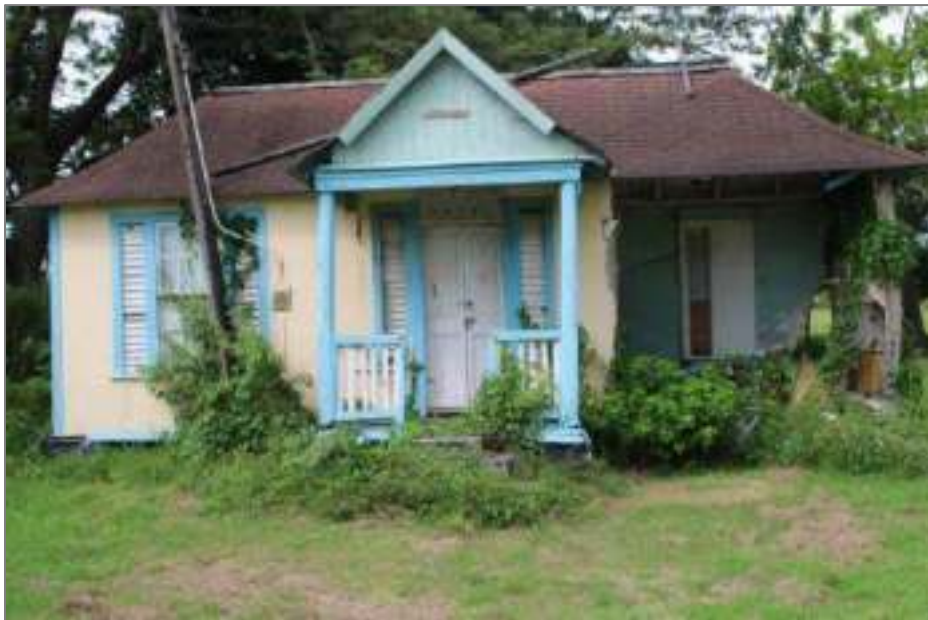
**Plate 4-109**      Historical guard house to the right of the entrance way to Paradise Park

Upon entering the zone from the main road at the western end, a traditional Jamaican vernacular guard house made of nog and Spanish walling is visible. The dilapidated structure features a hip roof with a secondary gable roofing style covered with shingles, a small veranda with wooden fretwork and jalousie windows. Four large cut stone columns and an iron gate inscribed with 'Paradise Park' mark the entrance. The driveway, lined with large palm trees, leads to the northwestern quadrant of Zone 4, which contains features associated with an 18th-century sugar plantation.

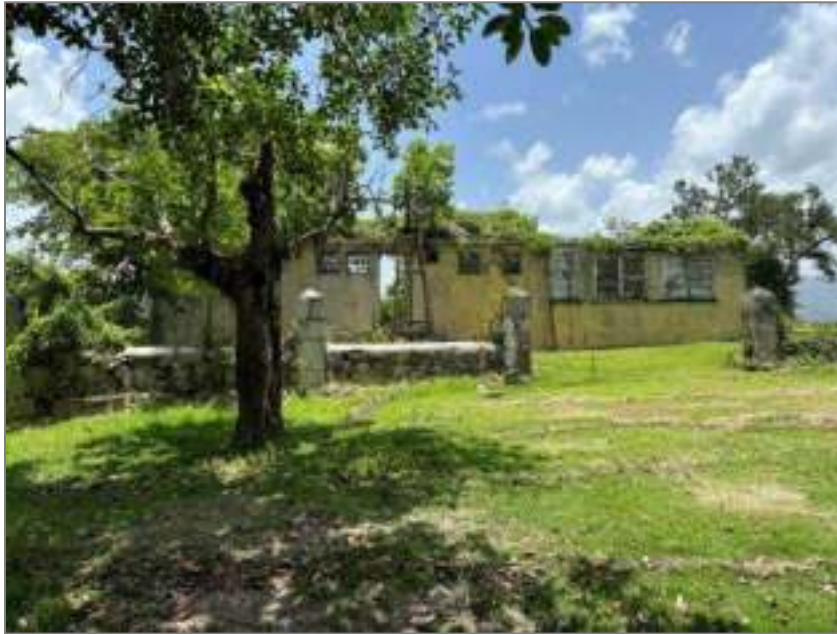
**Plate 4-112** Current photograph of the ruins of the Paradise Park Great House

The Paradise Park Great House, once grand, now sits in ruins. Facing south towards the sea, it was originally a single-storey wooden structure built on a cut stone foundation with a triple hip and pitch roof. The house was surrounded by a low-cut stone perimeter wall with columns. When the Clarke family acquired the property in 1952, modifications were made to turn the great house into a country club, including the addition of a swimming pool and new rooms. However, the house fell into disrepair and was partially demolished in the early 2000s.

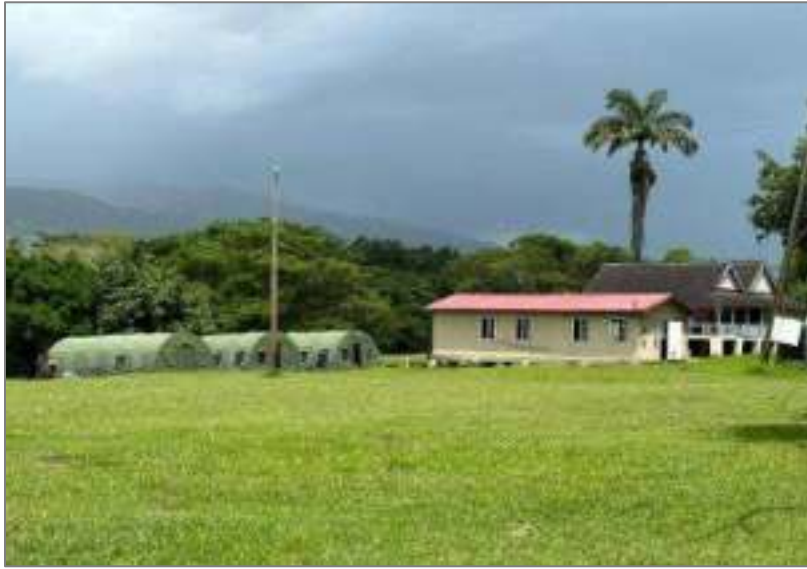
Plate 4-113      Wooden outbuildings and JDF tents (foreground) and the Overseer's House (background)

Southeast of the great house ruins is the overseer's house, a Jamaican vernacular structure with shiplap wood and a wraparound veranda with wooden rails. It has a double gable and pitch roof with glass sash windows and wooden louvres. The house is elevated on stone pillars with a cellar for storage. The front features an arched cut stone step with wooden rails leading to double French wooden doors. Several outbuildings are located behind the house, some in disrepair while others are still in use. The overseer's house is currently used by the Jamaica Defence Force as a military post for training. A modern wooden structure with a gable roof, located immediately north of the overseer's house, is also used by the JDF, along with three large army tents.

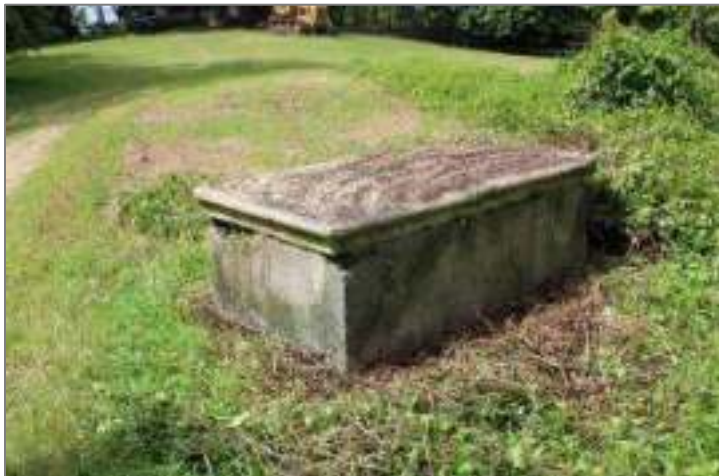
Plate 4-114      James Wedderburn's tomb

North of the cut stone building used as the garage and office for Paradise Park Limited is a historic grave. The tomb is made of cut stone and lime mortar, with later concrete rendering. It is oriented east to west with a marble headstone inscribed with the epitaph, "In the memory of James Wedderburn... who departed this life on the 17th of July 1797. Aged 45... This Tomb was erected by John Wedderburn."

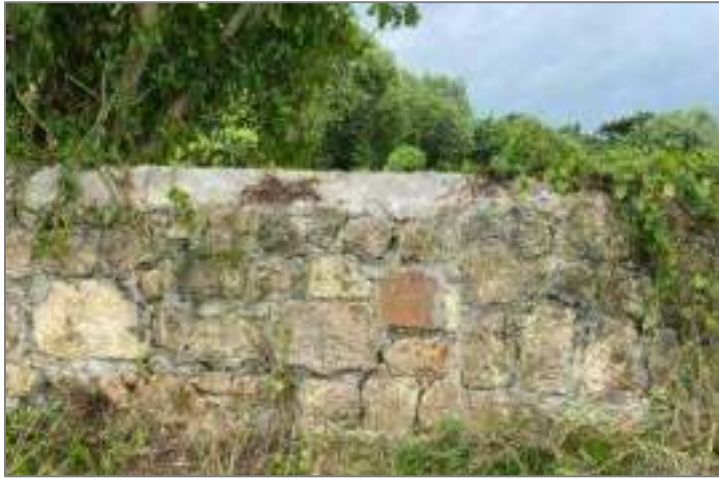
Plate 4-115 Section of cut stone wall with Spanish-era tile inclusion

Near the 18th-century plantation complex, remnants of a historic cattle pen constructed from cut stone and brick fragments are visible. The walls are filled with lime mortar and stand about 4 feet high. Some

walls have collapsed, and the pen is overgrown with trees and bushes. Spanish-era tile fragments incorporated into the pen walls suggest that it may have been used during the Spanish occupation of the land. The tiles were placed at consistent distances, possibly for decorative purposes.

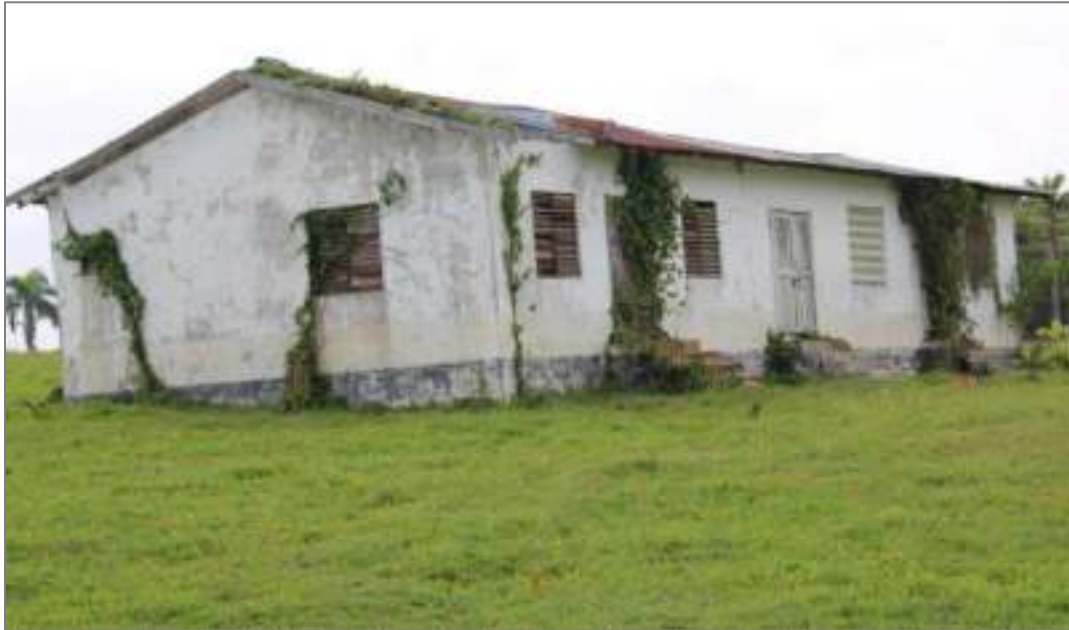
Plate 4-118 Old school building

In the centre of the zone is a single-storey building that served as a preparatory school in the 1990s. Constructed with concrete blocks and a zinc hip roof, it features wooden louvred windows and three main entrances with wooden French doors. The building is now abandoned and falling into disrepair, surrounded by land used for grazing cows.

An abandoned school building was once used as a preparatory school in the 1990s but is now left to deteriorate. The surrounding area is used for grazing, further adding to the agricultural use of the land (Jamaica National Heritage Trust, 2023). These activities are all managed within the framework of Paradise Park Limited, which also operates a golf course, horseback riding, and a tourist park area, reflecting the site's evolving use for leisure and tourism (Jamaica National Heritage Trust, 2023).

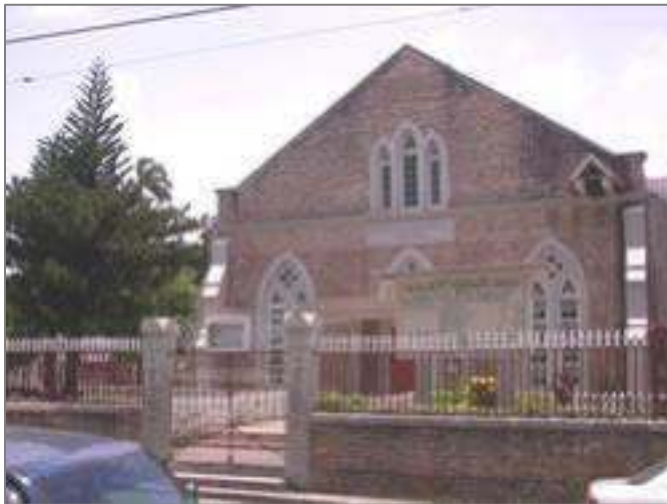
Plate 4-123 Savanna-La-Mar Baptist Church

**Savanna-La-Mar Baptist Church** (located approx. 3.6 km west of the proposed project area) – The Baptist Church in Savanna-la-mar was erected in 1835. It was destroyed by fire on the 23<sup>rd</sup> of November 1839 and rebuilt in 1840. The Church is very simple in architectural form with a rectangular floor plan. The facade is symmetrical with an arrangement of four-pointed arch window openings in the form of a crucifix. Two strategically placed projecting porches provide shelter for the entrances. There is an arrangement of five large, pointed arch windows on each side of the building. The roof is of a steep gable-ended construction (Plate 4-123).

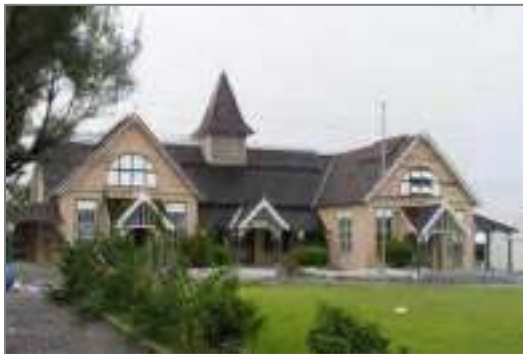
Plate 4-126 Manning's High School

The Thomas Manning Building is a delightful structure which is constructed from timber and the rest on a masonry plinth. Typical of the Georgian architecture, the building is perfectly symmetrical in elevation. However, for its function in the tropics, the Architect has added several features. On all sides the building has been fitted with deep verandas to add shade. The vented steep gable roof expels hot air, and a cupola with fixed shutters provide relief for any warm air trapped in the roof. The features combined have created a perfect example of colonial architecture (Plate 4-126).
